CASE STUDY 0004 - TalkTalk, Milton Keynes

Commercial Cladding Refurbishment

- ▶ **Date of Project:**
January - November 2020
- ▶ **Project Location:**
Breckland, Linford Wood, Milton Keynes
- ▶ **Project Type:**
Commercial Cladding Refurbishment.
- ▶ **Contract Type:**
Sub-Contractor
- ▶ **Contract Value:**
£505,000.00

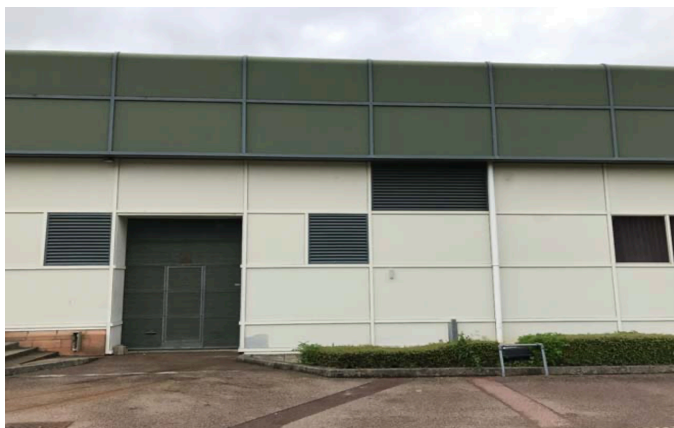
Before

The original ACM Cladding was installed to the building in the early 1980's and this system uses a pressure plate system with external gaskets to hold the cladding panels in place.

The cladding panels have had over 30 years of UV degradation and had caused the original factory applied coatings to break down.

Also due to lack of general maintenance there was a heavy film of dirt and organic matter present and the coating to GRP corner sections of the cladding system had completely broken down to chalky residue.

All panels had to be released due to the scope of works requiring the pressure plates to the cladding to be released to allow the gasket to be changed.

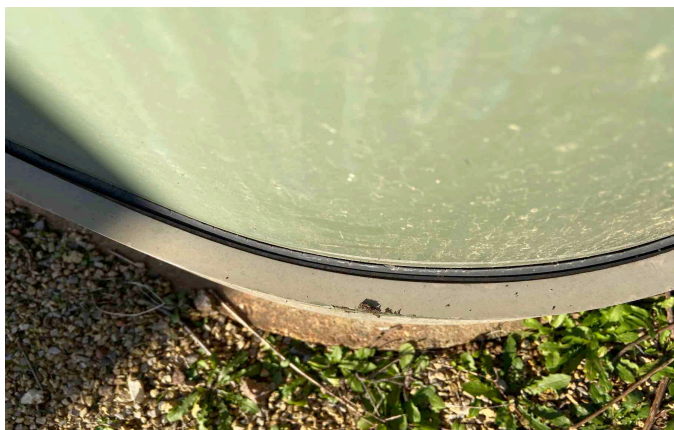
Before

The ACM cladding system is fitted with pressure plates that hold the panels in place and these pressure plates are fitted with two gaskets that run the length of the plates, these gaskets have been serving the system since its installation in the early 1980's and have now perished becoming brittle or completely broken down leaving the pressure plate exposed between the capping section and cladding.

Some areas have been spot repaired throughout with the heavy application of sealants to prevent water ingress, these sealants have also become a breeding ground for organic matter.

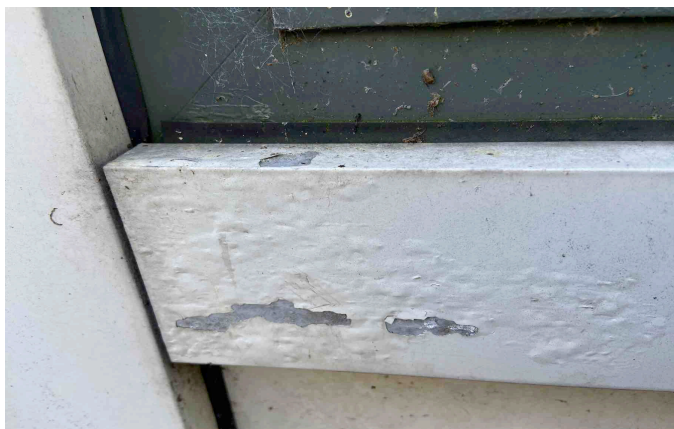
Before

The capping sections were also showing signs of UV degradation, de-lamination and corrosion, which would be typical with building this age, over 30 years exposed to the elements with little or no maintenance.
