CASE STUDY 00007 - The Range, Aylesbury

Commercial Roof & Cladding Refurbishment

CDSG01/0001

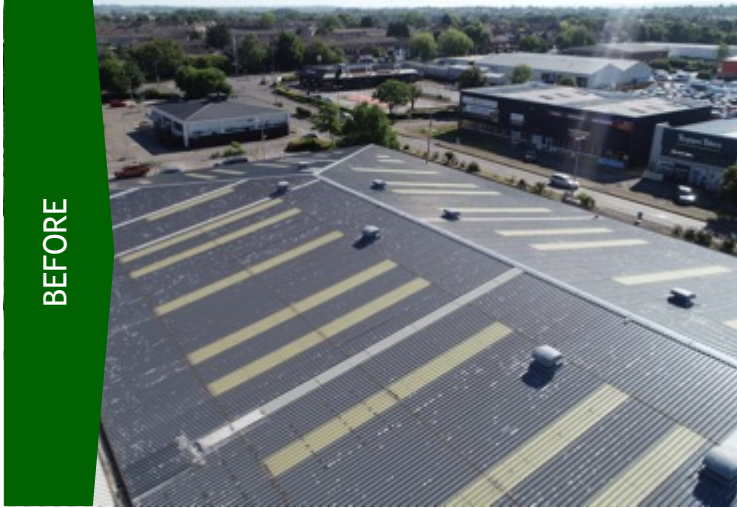
BEFORE

The metal pitch roof was heavily soiled due to little or no maintenance over the years, the original factory applied coating had started to fail with loose and flaking coatings throughout, with corrosion to the panel profiles and cut edges of the ridge, hip flashing and soaker sheets.

Some areas of the panels had also corroded leaving spot corrosion in the substrate, some of the roof fixings had become loose and other contractors had carried out historical patch repairs throughout.

There was various debris located all over the roof from animal activity such as small animal bones, bird nests and droppings present.

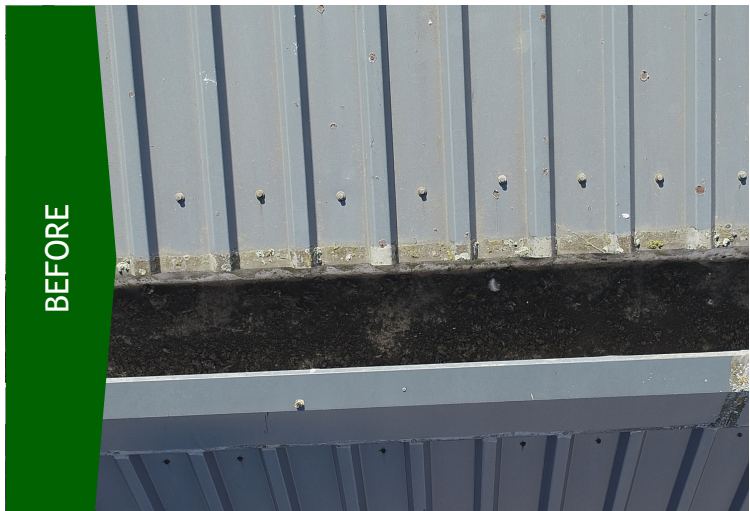
BEFORE

This building had 2 sets of gutters, with larger box gutters serving the main roof area and smaller perimeter gutters serving the mansard, all gutters had a fair amount of debris and leaking joints.

All commercial gutters are designed with a flow rate to deal with the flow of water efficiently, when gutter channels and outlets are blocked it means that during heavy rainfall the gutter channels will be overwhelmed, overflow and potentially find it way into the building by rising up over the upstands under any closures and down into voids which are not designed to take water.

Heavy debris can also enter the outlets, block and congest the downpipes causing unseen issues that can be costly to rectify.

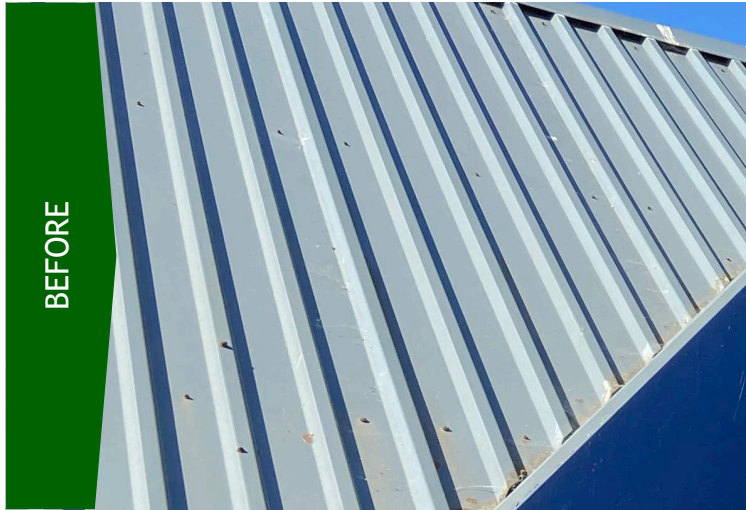
The existing mansard cladding, associated soffit panels had all been previously painted by hand, the after-market coatings had now come to the end of their serviceable life cycle with the paint films flaking and delaminating.

The cladding, fascia's and soffits also had a thick dirt film throughout, when left uncleaned for several years these films can slowly eat away at the coatings and cause premature failure.

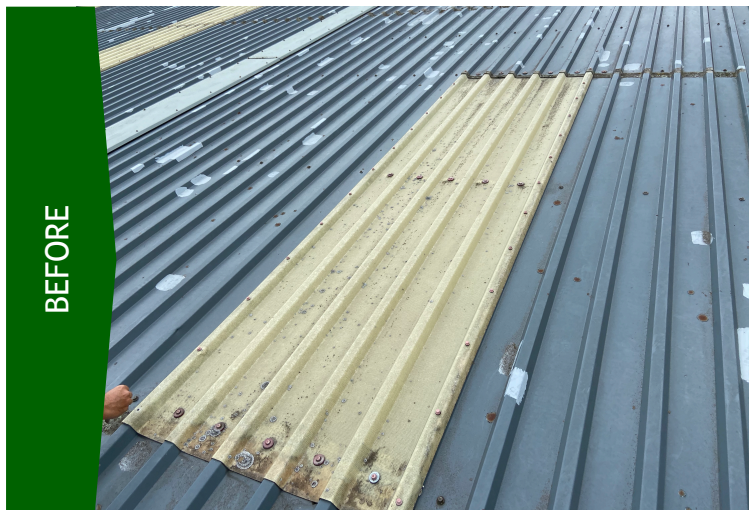
BEFORE

The existing GRP roof lights where covered by organic matter and had started to completely breakdown due to UV exposure and general weathering, the condition of the sheets stopped any type of day light transmitting into the areas below.

Not only does this reduce the light but makes the building consume more energy in lighting the warehouse during day light hours.

The GRP sheets had become completely fibrous and small holes and cracks had formed into the sheets causing water ingress on to areas below, there was also evidence of previous issues owing to various applications of sealants around the fittings and joints.

Owing to the roof works being completed above a live store and that internal obstructions limited the installation of safety netting, the outer roof lights sheets where upgraded to supasafe skins as an added fall protection measure.
