## **CASE STUDY 00002 - BT Fleet, Southampton**

Commercial Roof Refurbishment

- ▶ **Date of Project:**  
September - November 2019
- ▶ **Project Location:**  
BT TEC & Fleet, Nursling Industrial Estate,  
Southampton.
- ▶ **Project Type:**  
Commercial Roof Refurbishment.
- ▶ **Contract Type:**  
Sub-Contractor
- ▶ **Contract Value:**  
£110,000.00

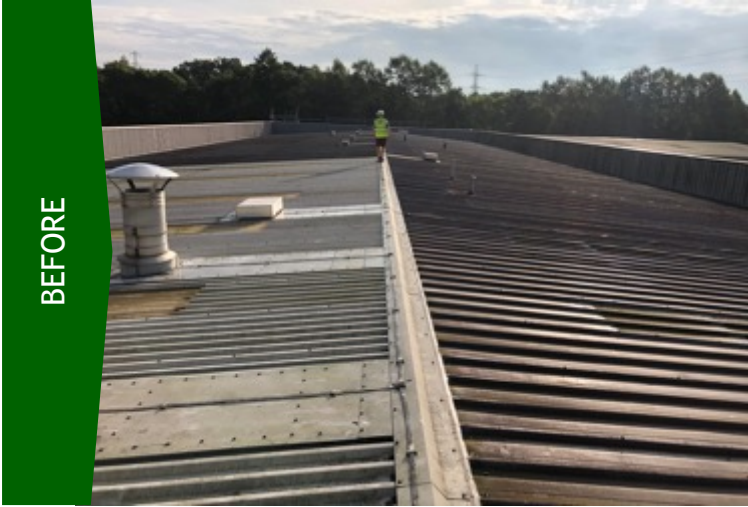
BEFORE

The composite roof was heavily soiled due to little or no maintenance over the years, the original factory applied coated had started to fail with loose and flaking coatings throughout, with corrosion to the panel profiles and cut edges of the ridge, hip flashing and soaker sheets.

Some areas of the panels had also corroded leaving small holes in the substrate, most of the roof fixings had become loose and the plastic cover caps had completely perished or washed away.

There was various debris located all over the roof from animal activity such as small animal bones, bird nests and droppings present.

With such harsh environments on the south coast and the accelerated corrosion that it presents, any commercial building if not maintained regularly will be subject to premature corrosion and ultimately a reduction in the life cycle of its components.

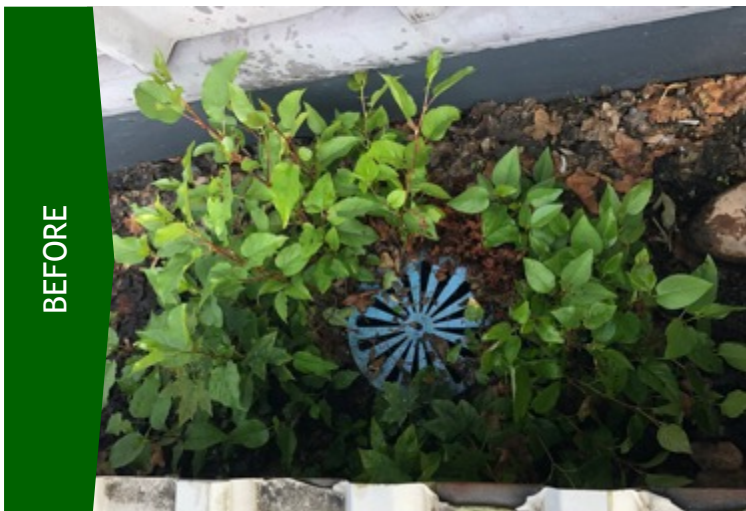
BEFORE

The gutters to the roof were in quite a bad condition, with high levels of debris, silt and vegetation in the gutter valleys, most of the outlets where obstructed or completely covered. Little or no maintenance can cause the gutters to become overwhelmed by vegetation which in return causes excessive weight on the gutter boxes which can open the box gutter joints causing leakage and water ingress, the moisture and standing water can accelerate corrosion.

All commercial gutters are designed with a flow rate to deal with the flow of water efficiently, when gutter channels and outlets are blocked it means that during heavy rainfall the gutter channels will be overwhelmed, overflow and potentially find it way into the building by rising up over the upstands under any closures and down into voids which are not designed to take water.

Heavy debris can also enter the outlets, block and congest the downpipes causing unseen issues that can be costly to rectify.

It is important that regular maintenance is planned and undertaken annually to prevent unnecessary and excessive remedial costs.

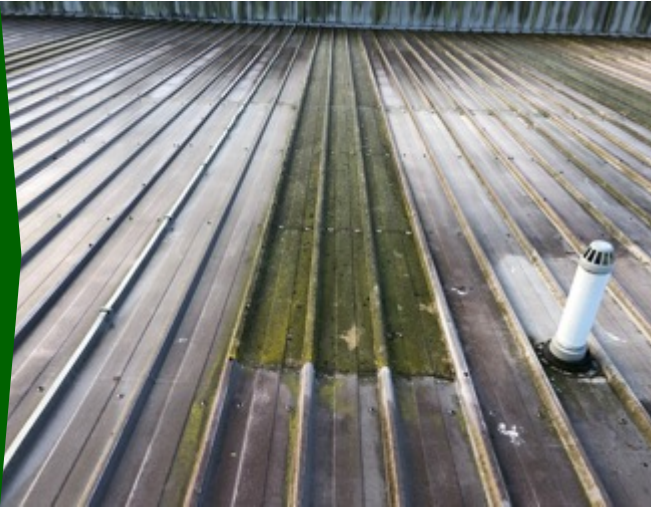
BEFORE

The existing GRP roof lights where covered by organic matter and had started to completely breakdown due to UV exposure and general weathering, the condition of the sheets stopped any type of day light transmitting into the areas below.

Not only does this reduce the light but makes the building consume more energy in lighting the warehouse during day light hours.

The GRP sheets had become completely fibrous and small holes and cracks had formed into the sheets causing water ingress on to areas below, there was also evidence of previous issues owing to various applications of sealants around the fittings and joints.

There was also several lights that were redundant due to being located over offices which celling tiles installed.
