CASE STUDY 00002 - BT Fleet, Southampton

Commercial Roof Refurbishment

ACCL01/0001

- ▶ **Date of Project:**
September - November 2019
- ▶ **Project Location:**
BT TEC & Fleet, Nursling Industrial Estate,
Southampton.
- ▶ **Project Type:**
Commercial Roof Refurbishment.
- ▶ **Contract Type:**
Sub-Contractor
- ▶ **Contract Value:**
£110,000.00

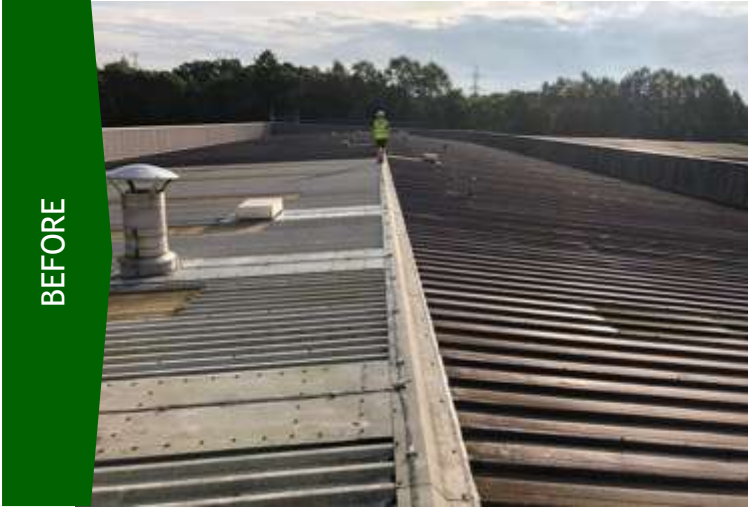
BEFORE

The existing composite roof was in a poor condition with many years of neglect from maintenance, there was various areas of corrosion that had caused holes in the roof sheets that had to be addressed prior to coatings and cut edge corrosion throughout the sheets and flashing details.

The composite roof was heavily soiled due to little or no maintenance over the years, the original factory applied coating had started to fail with loose and flaking coatings throughout, with corrosion to the panel profiles and cut edges of the ridge, hip flashing and soaker sheets.

Some areas of the panels had also corroded leaving small holes in the substrate, most of the roof fixings had become loose and the plastic cover caps had completely perished or washed away.

There was various debris located all over the roof from animal activity such as small animal bones, bird nests and droppings present.

With such harsh environments on the south coast and the accelerated corrosion that it presents, any commercial building if not maintained regularly will be subject to premature corrosion and ultimately a reduction in the life cycle of its components.

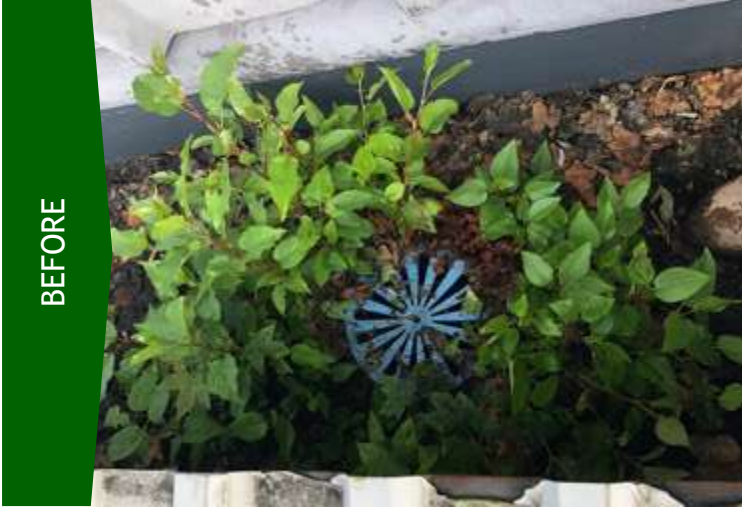
BEFORE

The gutters to the roof were in quite a bad condition, with high levels of debris, silt and vegetation in the gutter valleys, most of the outlets were obstructed or completely covered. Little or no maintenance can cause the gutters to become overwhelmed by vegetation which in return causes excessive weight on the gutter boxes which can open the box gutter joints causing leakage and water ingress, the moisture and standing water can accelerate corrosion.

All commercial gutters are designed with a flow rate to deal with the flow of water efficiently, when gutter channels and outlets are blocked it means that during heavy rainfall the gutter channels will be overwhelmed, overflow and potentially find its way into the building by rising up over the upstands under any closures and down into voids which are not designed to take water.

Heavy debris can also enter the outlets, block and congest the downpipes causing unseen issues that can be costly to rectify.

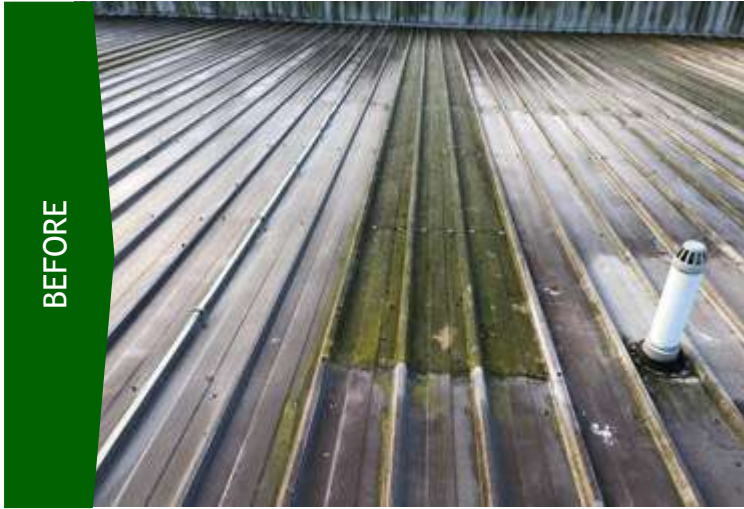
BEFORE

The existing outer roof lights had been effected by UV degradation and general wear and tear, as a result they could not transmitting any natural day light into the warehouse's below.

The existing GRP roof lights were covered by organic matter and had started to completely breakdown due to UV exposure and general weathering, the condition of the sheets stopped any type of day light transmitting into the areas below.

Not only does this reduce the light but makes the building consume more energy in lighting the warehouse during day light hours.

The GRP sheets had become completely fibrous and small holes and cracks had formed into the sheets causing water ingress on to areas below, there was also evidence of previous issues owing to various applications of sealants around the fittings and joints.

There was also several lights that were redundant due to being located over offices which ceiling tiles installed.
