## **CASE STUDY 00016 - Discovery Retail Park, Grantham**

Commercial Roof and Gutter Refurbishment

SAND01/0008

- ▶ **Date of Project:**  
November 2001 - January 2022
- ▶ **Project Location:**  
Discovery Retail Park, Grantham
- ▶ **Project Type:**  
Commercial Roof, Cladding and Glazing  
Frame Refurbishment.
- ▶ **Contract Type:**  
Sub-Contractor
- ▶ **Contract Value:**  
£52,000.00

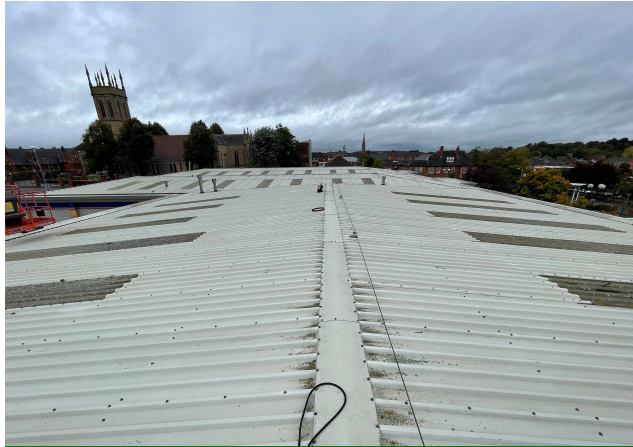
Before

The existing factory applied coating to the roof area was soiled and starting to breakdown through UV exposure and general weathering.

Cut edge corrosion was present throughout the roof and causing the roof sheet coatings to peel back exposing the steel substrate.

Many of the roof fixing caps were missing and loose fixings throughout.

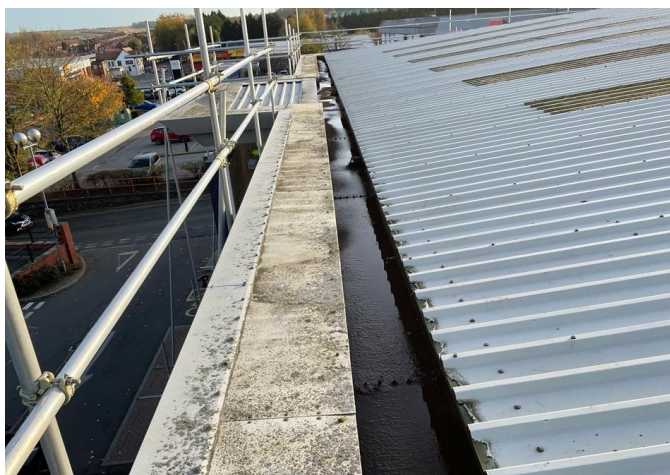
Before

The existing perimeter capping's were covered in a thick film of dirt that had accumulated over many years; the metal sections had advanced levels of cut edge corrosion present to both the joints of the capping's and the overlapping edge of the fascia's at roof level.

The end client had original requested to have these replaced not being conscious at the time that the elevational fascia's also were affected by the corrosion, which would have been a large cost increase to replace.

We suggested that we could provide a liquid treatment and bring then inline with the roof coating treatment and provide a 20-year guarantee, saving time and money.

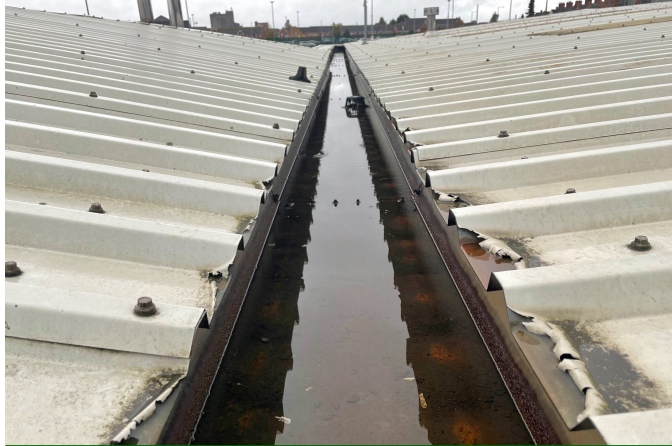
Before

The perimeter gutters were in a typical state with a build up of silt and standing water caused by detritus building up around the bottom of the leaf guards over the gutter outlets causing damming.

The metal box gutters had varying amounts of red oxide build up throughout.

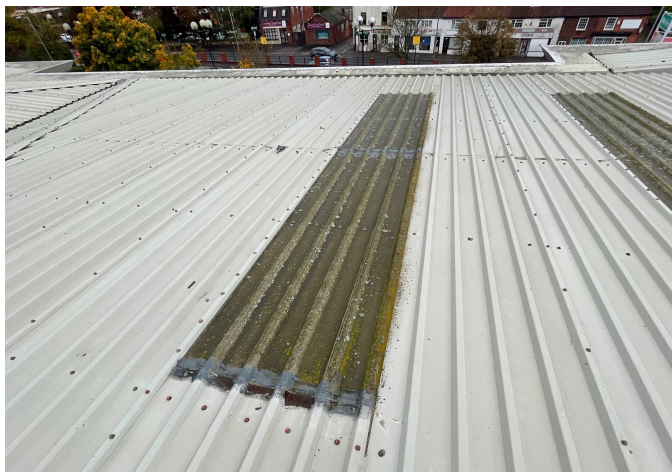
Before

The existing outer skin on the GRP roof light sheets had eroded and started to perish due to UV exposure and general weathering, the condition of the sheets had seriously reduced the amount of natural day light transmission into the building below.

There was historical water ingress issues around the sky lights with various patch repairs evident throughout.

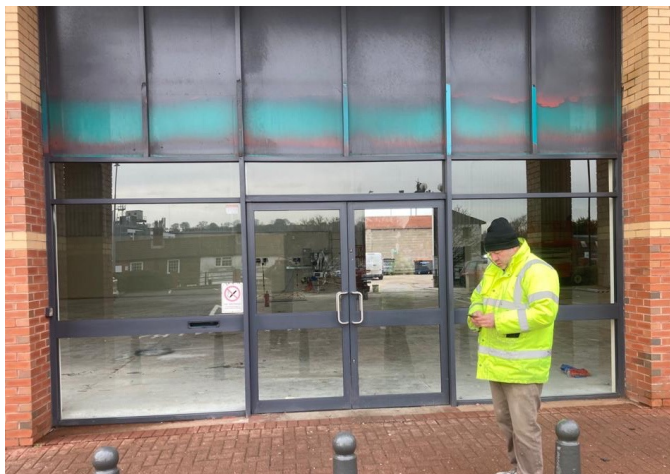
Before

The main entrance screens to the unit had been previously painted to a poor standard and had vinyl applied to the glass above the entrance, there was also large redundant fixing holes following the removal of signage.

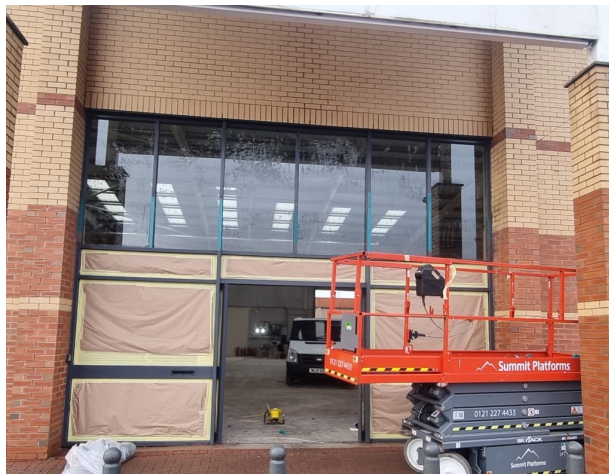
In Progress

The vinyl was removed from the glazing above which left stains and surface damage to the glass.

The frames were sanded back to a firm edge ensuring that all loose coatings and obvious sags and drips created from previous coatings applied were removed and taken back.

The redundant fixing holes were then filled using a two-part body filler and then sanded back flush.

The frames required hand cleaning and degreasing to from all contaminates and silica.

All immediate areas around the entrance including glazing was then masked up in readiness for the application of the coating system.

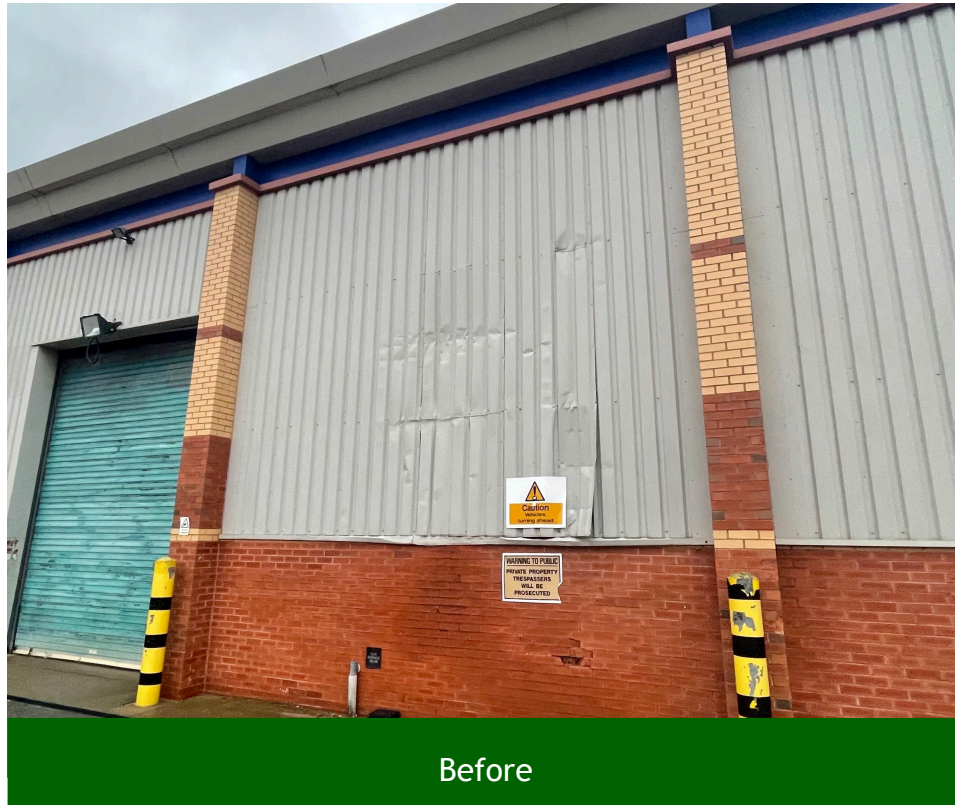
Before

Owing to the removal of services and flues the property was left with cladding and roofing sheets with large penetrations, also there was a large section of cladding and drip sills that had been impact damaged to the rear elevation.
