CASE STUDY 00001 - Mail House, Kempston

Commercial Building Envelope Refurbishment

PARA01/0001

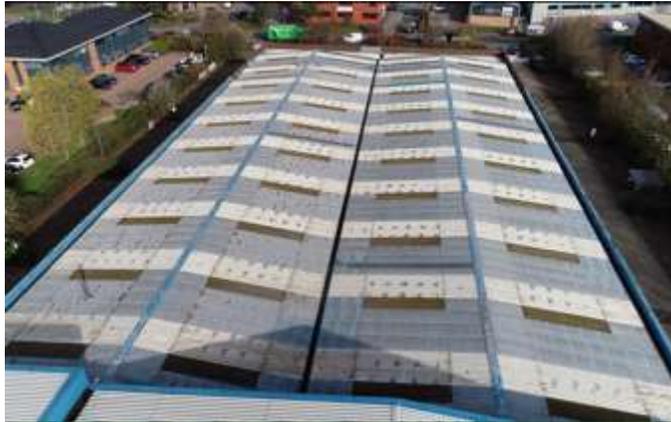
Before

The original factory applied coatings to the metal sheets has had completely perished due years of degradation owing to UV exposure and general weathering.

There was various surface corrosion and ginging through out the roof, the flashings and capping's to the system where also suffering from degradation.

The roof sheets and flashing all suffered from cut end corrosion that would need to be addressed prior to coating the roof area.

There was also a need to remove 26 existing flues that penetrated the roof and make good the roof sheets.

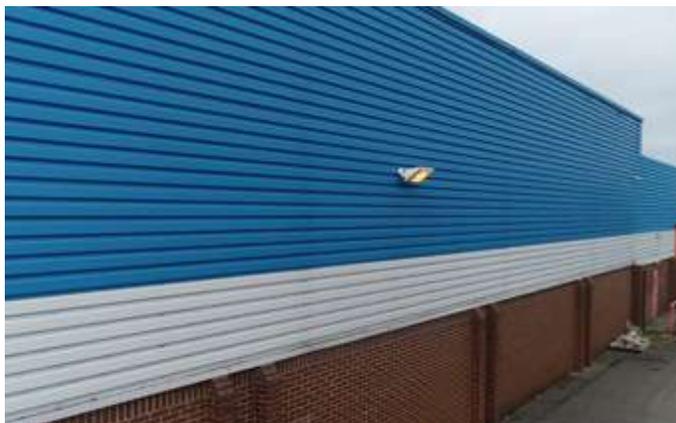
Before

The existing trapezoidal cladding sheets were blue and white in colour, the existing coatings at time of survey had been hand applied.

The coatings had weathered and showed signs of degradation with loose de-laminated areas of paint to the top edges of the profile.

Redundant fixing holes and flue penetrations would need to be addressed prior to the application of coatings, there was also large areas of impact damage to a small quantity of cladding sheets, drip and delivery door flashings.

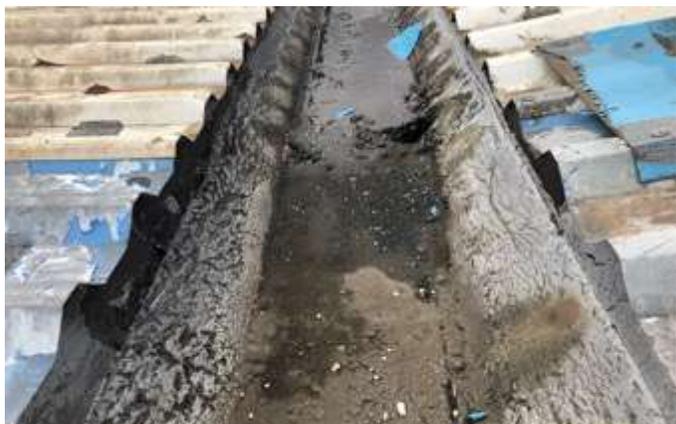
Before

The existing gutters to the main warehouse roof has received various treatments of the years which left a cracked and unworkable substrate, the thick layers of treatment would require a significant amount of labour to completely remove and no guarantees to what would be left of the gutter.

The gutters to the warehouse extension high roof was installed as part of the extension and had not received any treatments, however due to lack of maintenance the joints were leaking and causing water ingress to the warehouse directly below.

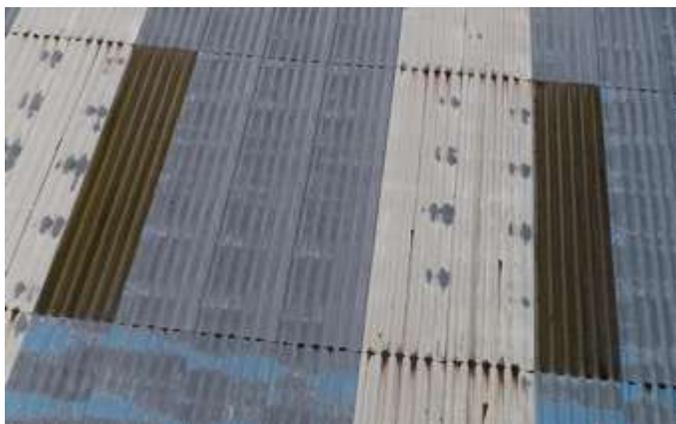
Before

The existing outer GRP roof light sheets had eroded and started to breakdown due to UV exposure and general weathering, the condition of the sheets had seriously reduced the amount of natural day light that could transmit through the GRP and into the warehouse.

Not only does this reduce the light but makes the building consume more energy in lighting the warehouse during day light hours.

The GRP sheets had become fibrous and small holes and cracks had formed into the outer sheets causing water ingress on to the inner sheets below.

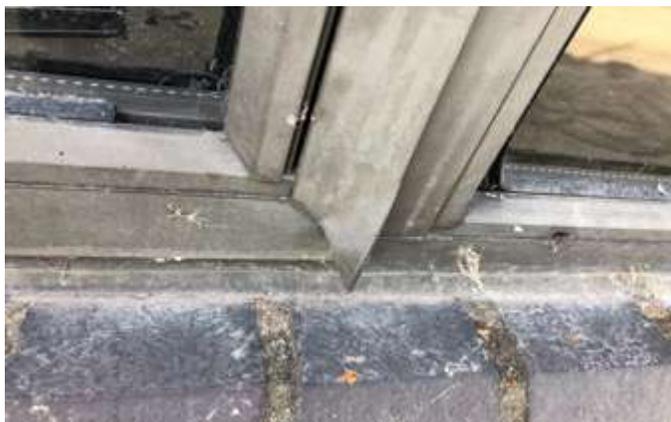
Before

The glazing frames to the windows and doors on the office block to the front of the building were looking tired and worn, the powder coated coatings had eroded due to UV exposure and chalked, on touch you could rub the surface and a white residue would transfer.

The gaskets to the doors and windows had perished and were hanging loose throughout, there were areas that impact damage and the windowsills had begun to corded with areas of coatings that had failed and ginging and surface corrosion present.
