CASE STUDY 0004 - TalkTalk, Milton Keynes

Commercial Cladding Refurbishment

- ▶ **Date of Project:**
January - November 2020
- ▶ **Project Location:**
Breckland, Linford Wood, Milton Keynes
- ▶ **Project Type:**
Commercial Cladding Refurbishment.
- ▶ **Contract Type:**
Sub-Contractor
- ▶ **Contract Value:**
£505,000.00

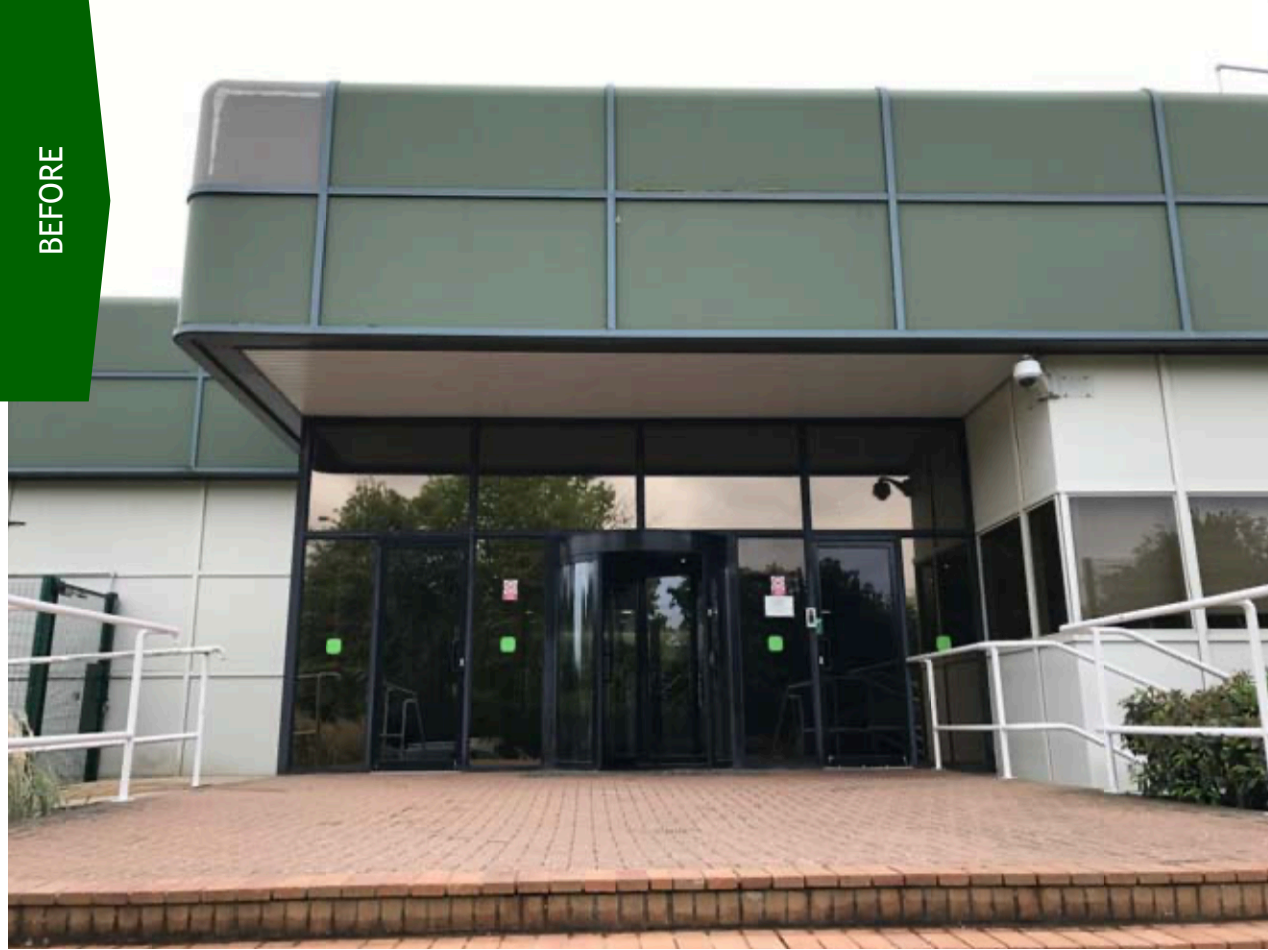
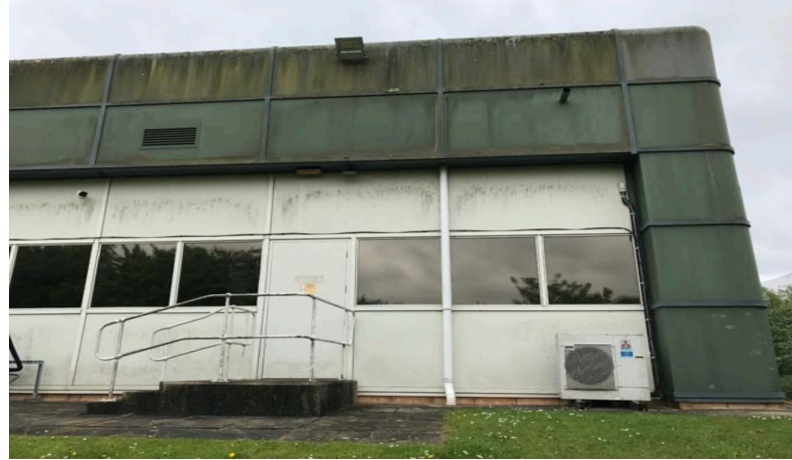
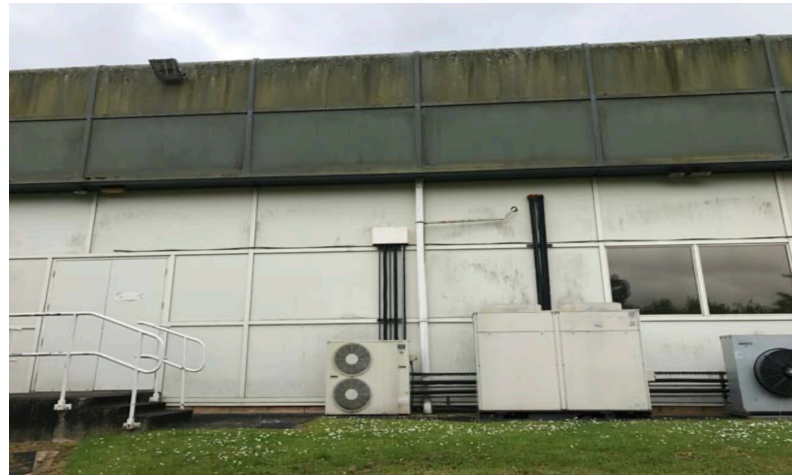
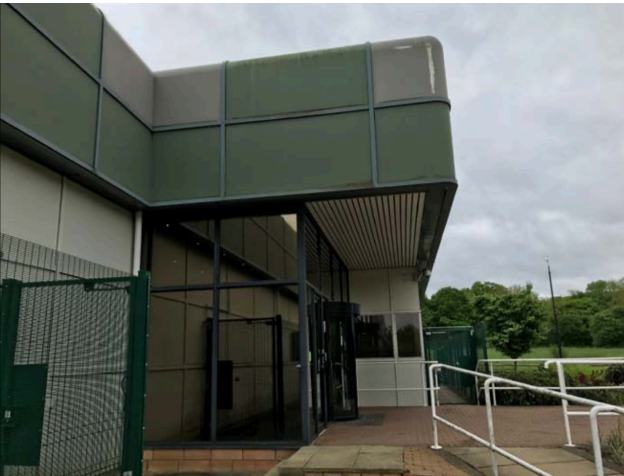
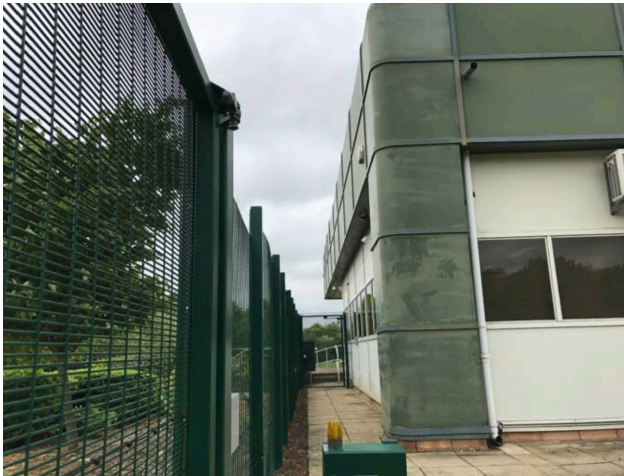
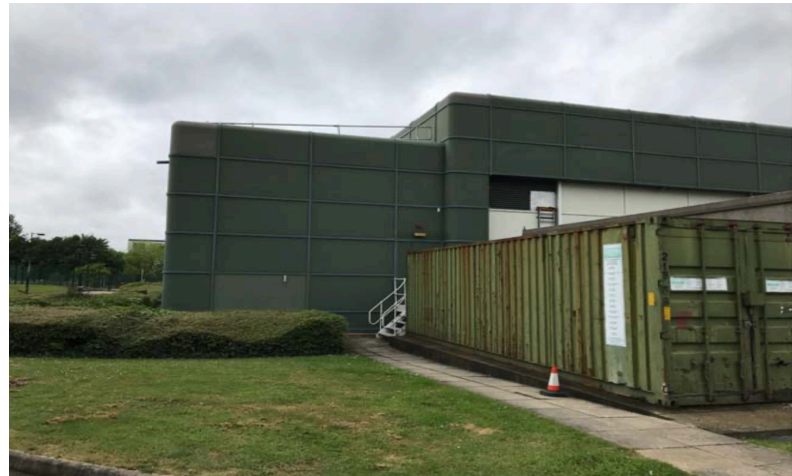
BEFORE

The gaskets to the ACM cladding system had perished throughout the building allowing water ingress into building voids, leak fixes were present throughout the elevations and evident through the many areas that has sealant applied to prevent water ingress. However the wrong type of sealant had been used an organic matter had began to grow and populate. 16,000 Lm of gasket was replaced with new to the pressure plates, this included racking out all old and previously applied sealants.

The ACM cladding system is fitted with pressure plates that hold the panels in place and these pressure plates are fitted with two gaskets that run the length of the plates, these gaskets have been serving the system since its installation in the early 1980's and have now perished becoming brittle or completely broken down leaving the pressure plate exposed between the capping section and cladding.

Some areas have been spot repaired throughout with the heavy application of sealants to prevent water ingress, these sealants have also become a breeding ground for organic matter.

The capping sections were also showing signs of UV degradation, de-lamination and corrosion, which would be typical with building this age, over 30 years exposed to the elements with little or no maintenance.
