CASE STUDY 00007 - The Range, Aylesbury

Commercial Roof & Cladding Refurbishment

CDSG01/0001

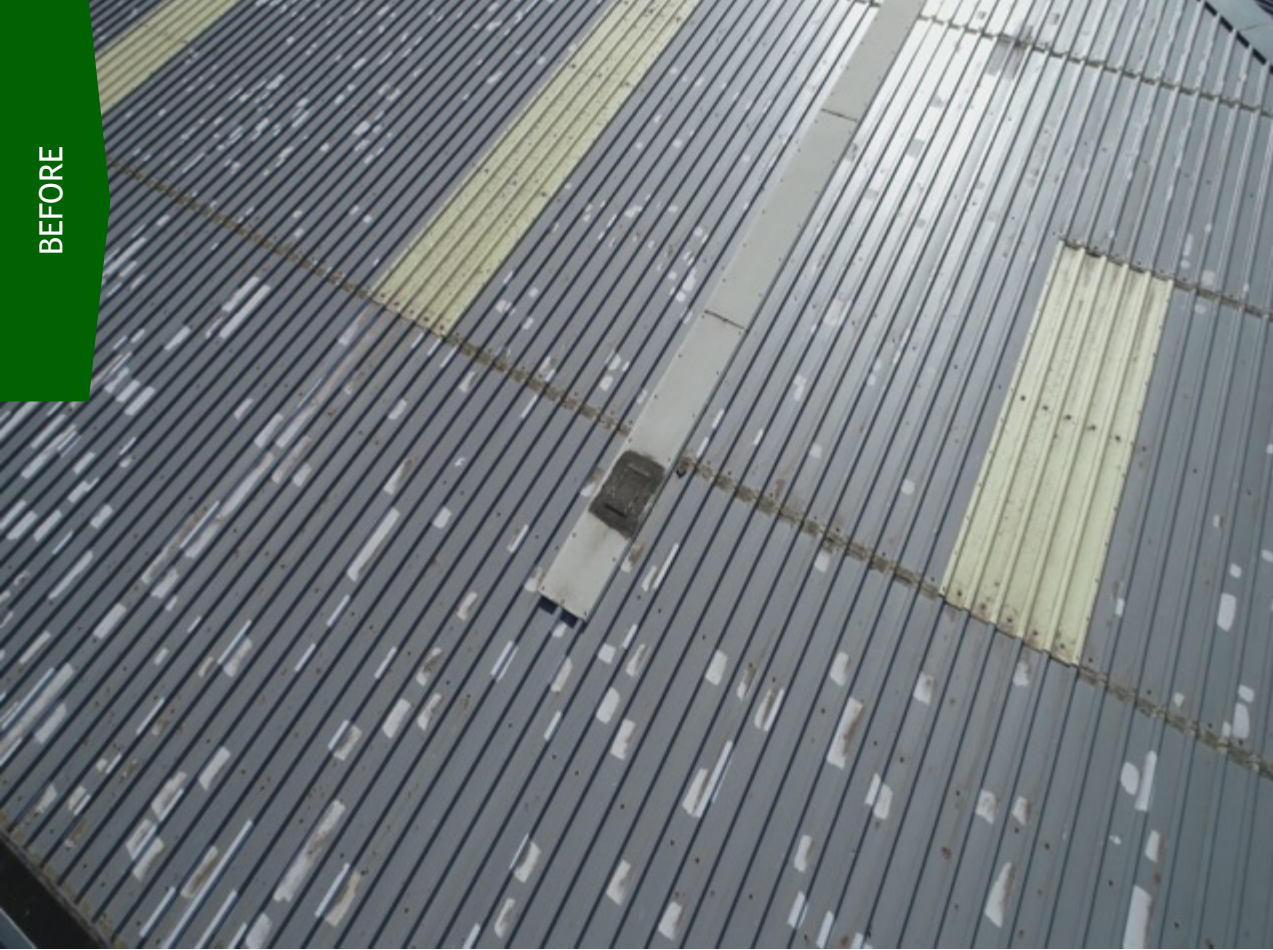
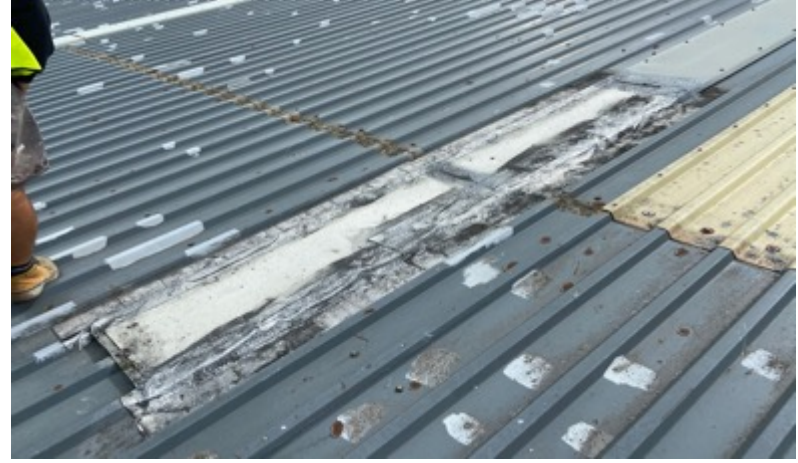
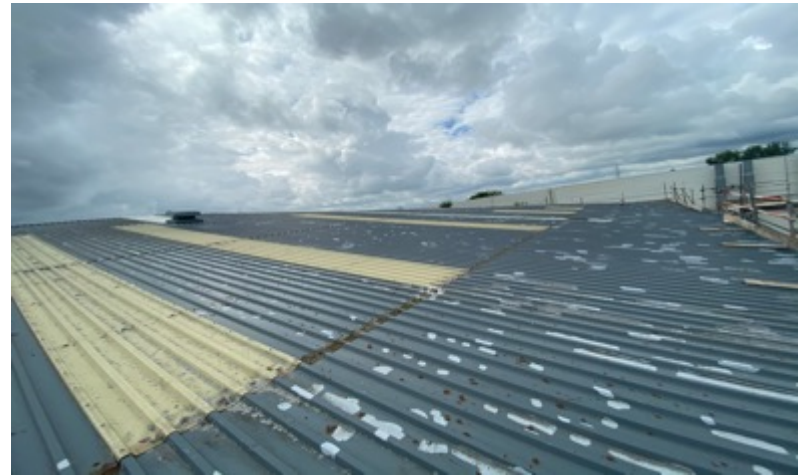
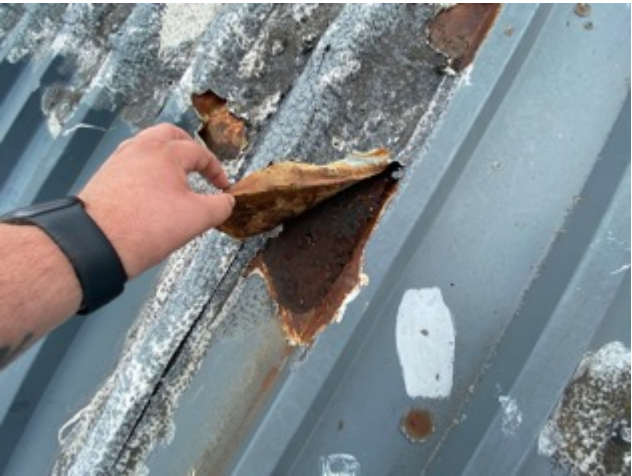
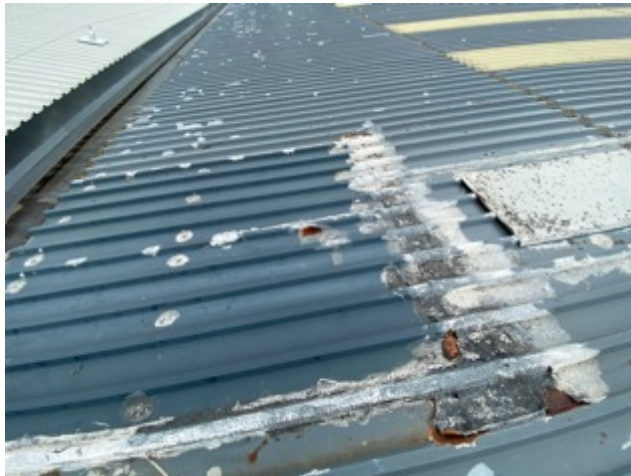
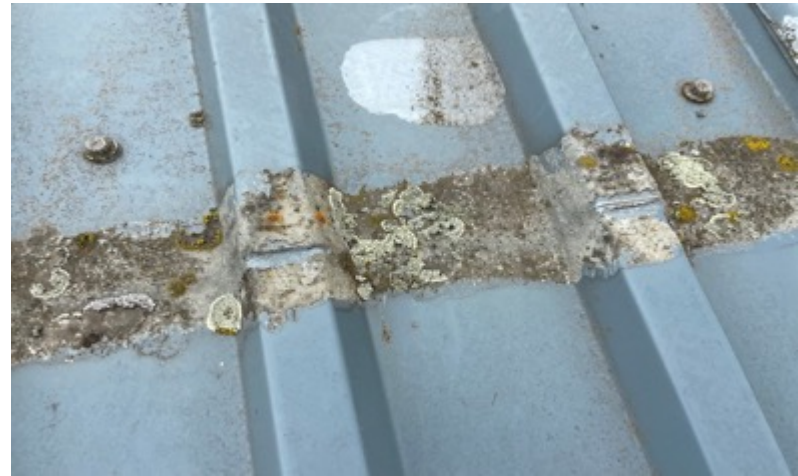
BEFORE

The existing GRP roof lights where covered by organic matter and had started to completely breakdown due to UV exposure and general weathering, the condition of the sheets stopped any type of day light transmitting into the areas below.

The GRP sheets had become completely fibrous and small holes and cracks had formed into the sheets causing water ingress on to areas below, there was also evidence of previous issues owing to various applications of sealants around the fittings and joints.

The existing outer roof lights had been effected by UV degradation and general wear and tear, as a result they transmitted a limited mount of natural day light into the store below, new Filon Supersafe outer GRP sheets where fitted to replace the existing degraded sheets.

The GRP roof lights fitted came complete with a 25-year life expectancy.
