## **CASE STUDY 00002 - BT Fleet, Southampton**

Commercial Roof Refurbishment

- ▶ **Date of Project:**  
September - November 2019
- ▶ **Project Location:**  
BT TEC & Fleet, Nursling Industrial Estate,  
Southampton.
- ▶ **Project Type:**  
Commercial Roof Refurbishment.
- ▶ **Contract Type:**  
Sub-Contractor
- ▶ **Contract Value:**  
£110,000.00

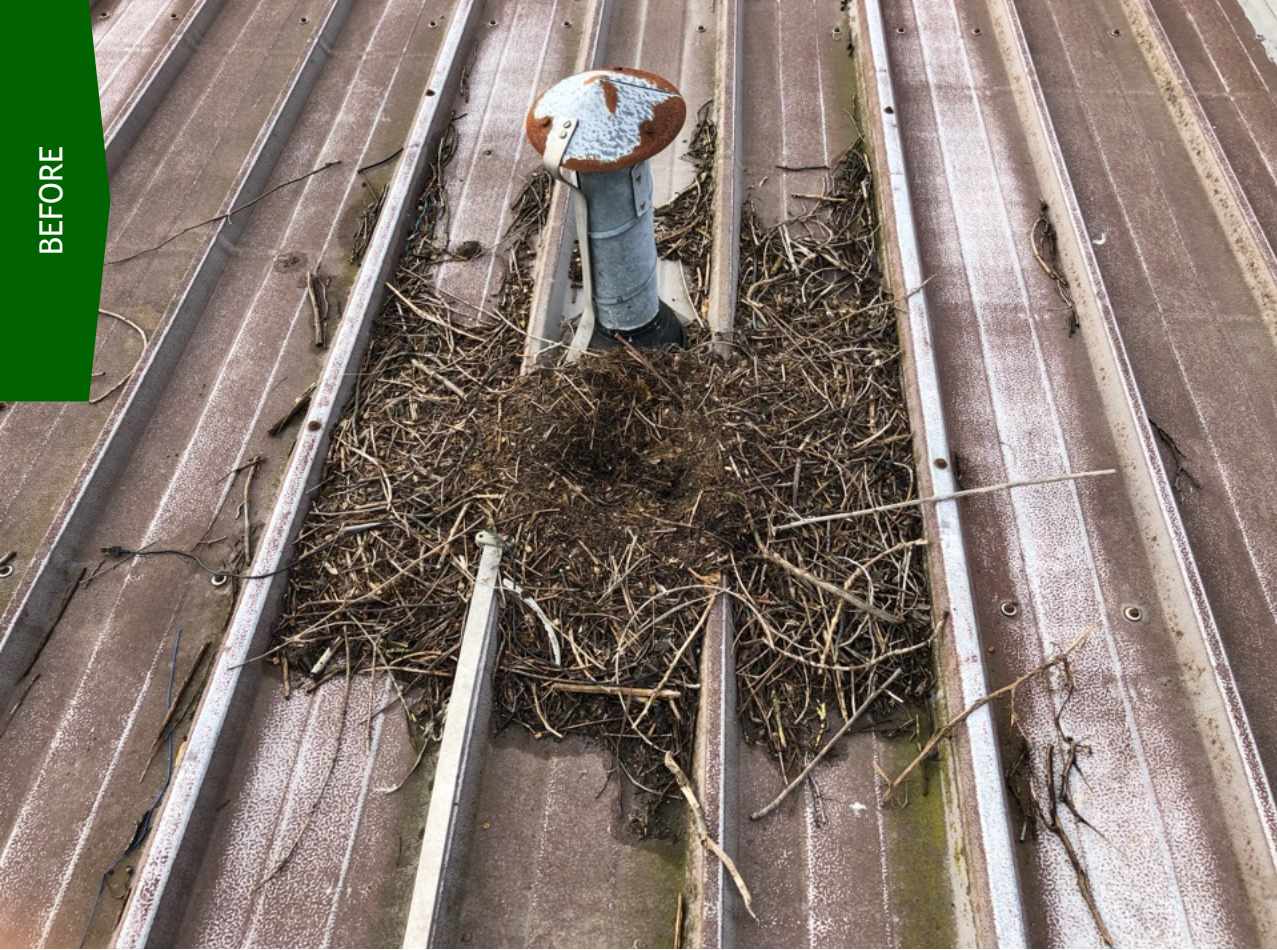
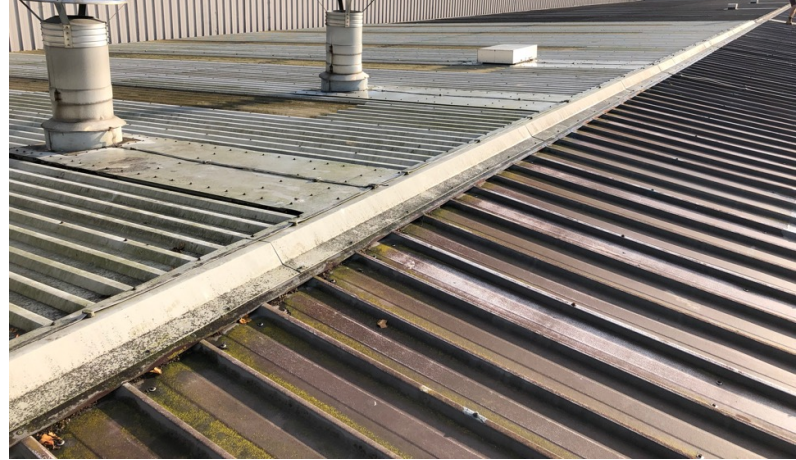
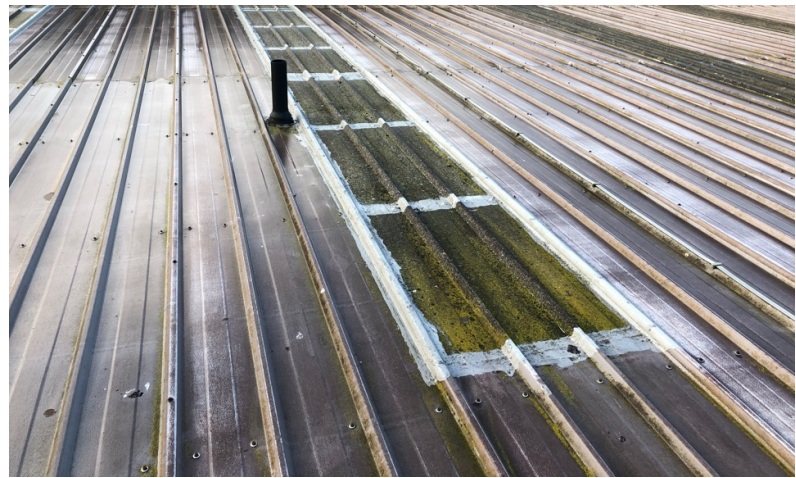
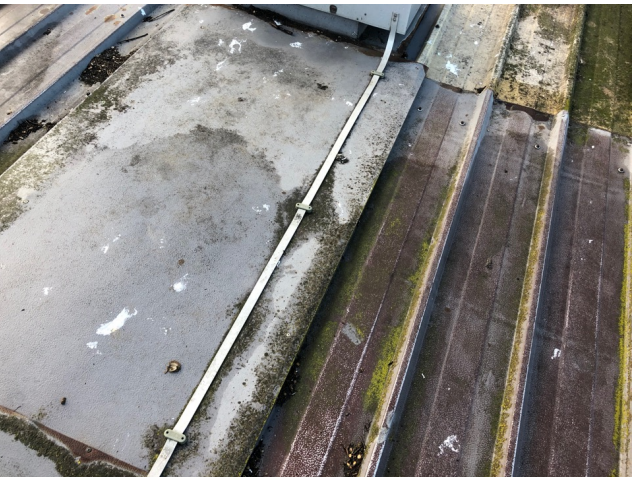
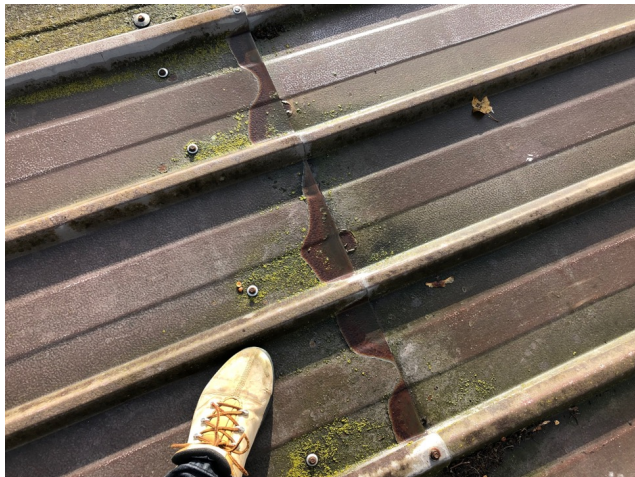
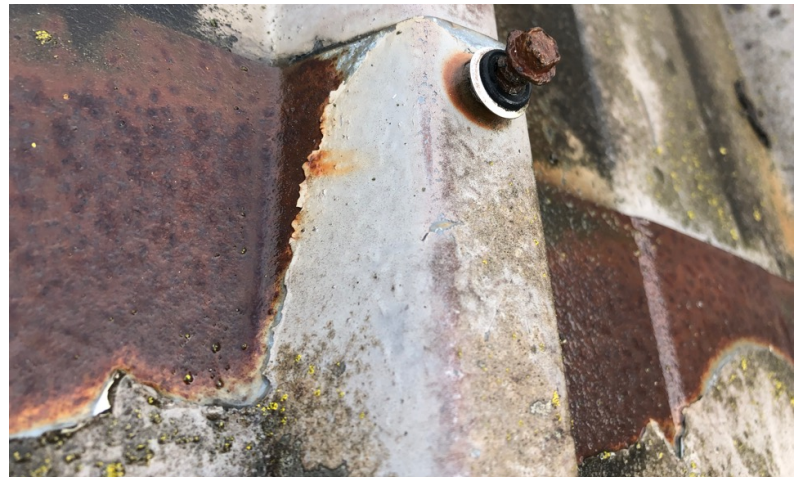
BEFORE

The existing GRP roof lights where covered by organic matter and had started to completely breakdown due to UV exposure and general weathering, the condition of the sheets stopped any type of day light transmitting into the areas below.

The GRP sheets had become completely fibrous and small holes and cracks had formed into the sheets causing water ingress on to areas below, there was also evidence of previous issues owing to various applications of sealants around the fittings and joints.
