CASE STUDY 00002 - BT Fleet, Southampton

Commercial Roof Refurbishment

ACCL01/0001

- ▶ **Date of Project:**
September - November 2019
- ▶ **Project Location:**
BT TEC & Fleet, Nursling Industrial Estate,
Southampton.
- ▶ **Project Type:**
Commercial Roof Refurbishment.
- ▶ **Contract Type:**
Sub-Contractor
- ▶ **Contract Value:**
£110,000.00

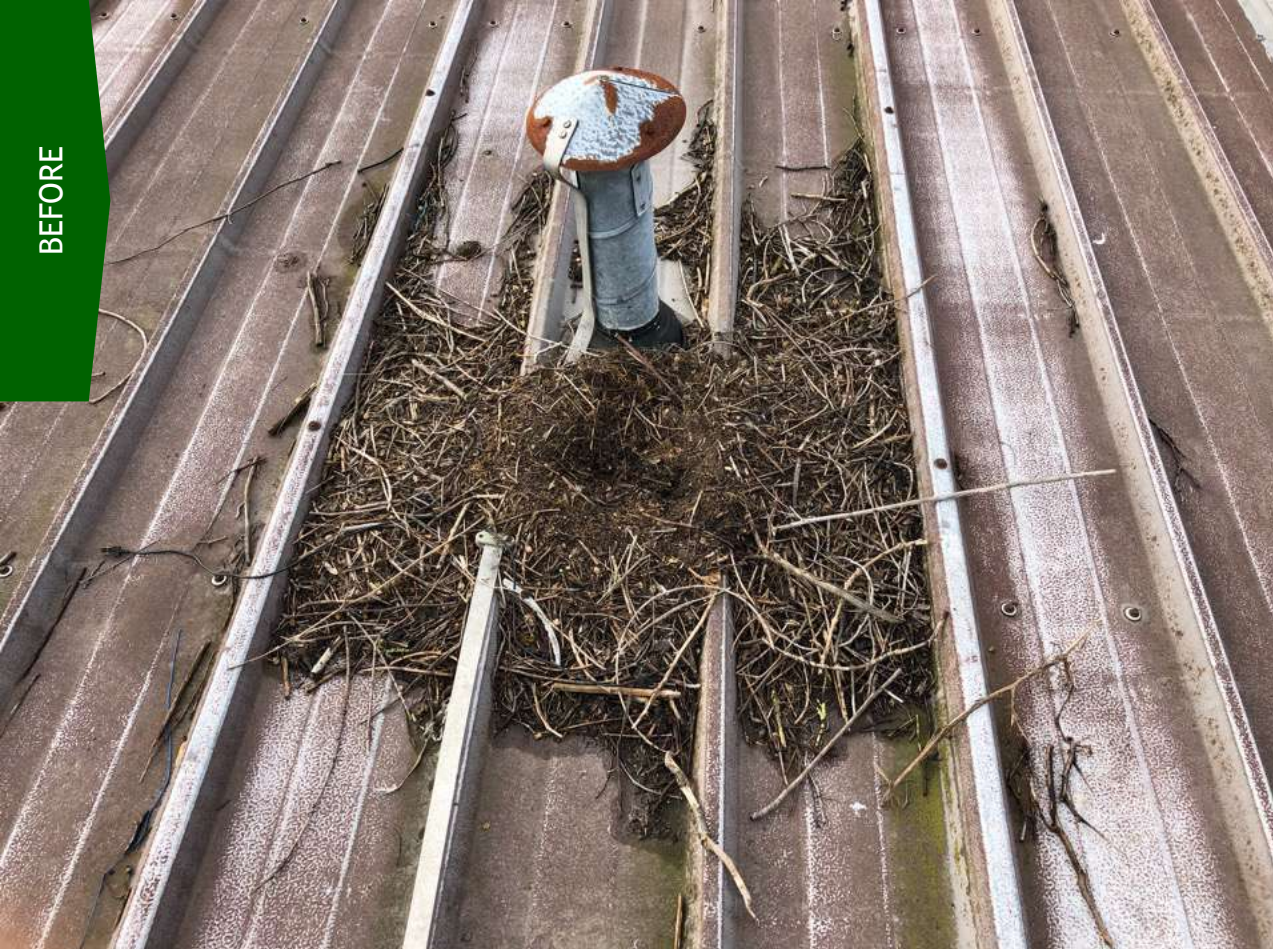
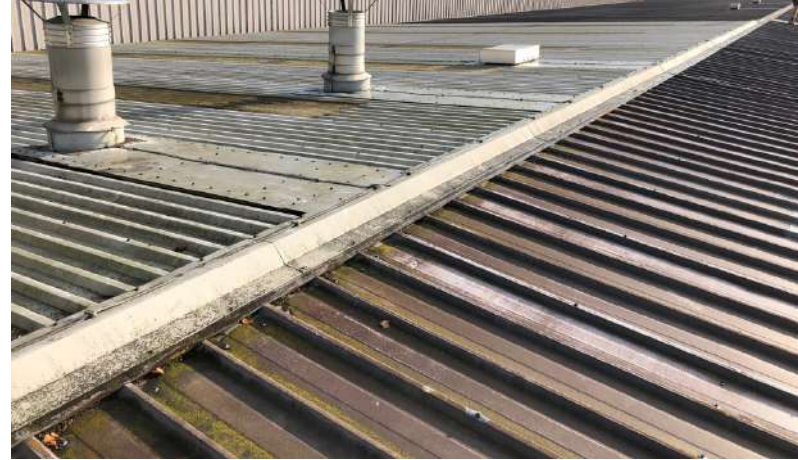
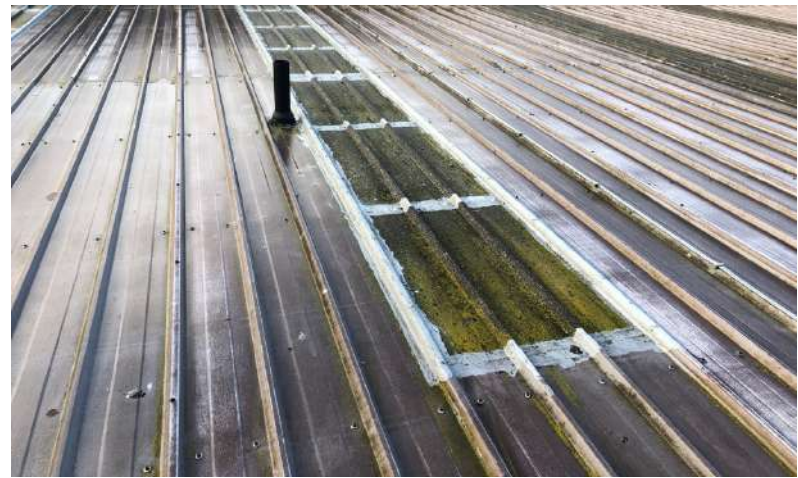
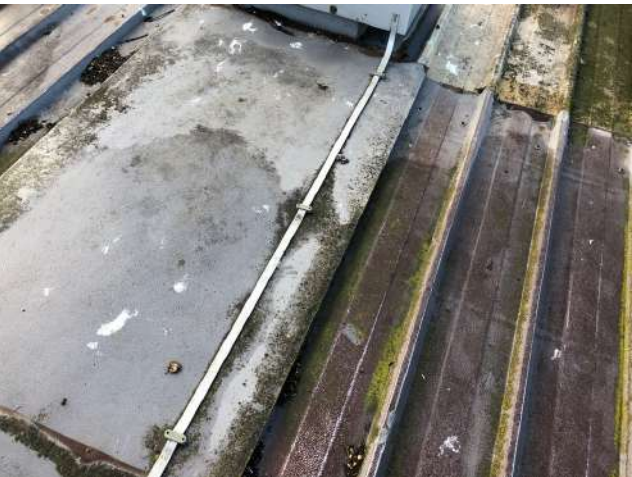
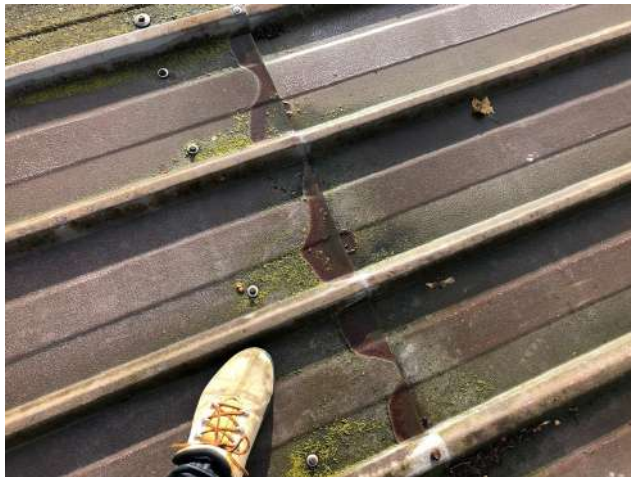
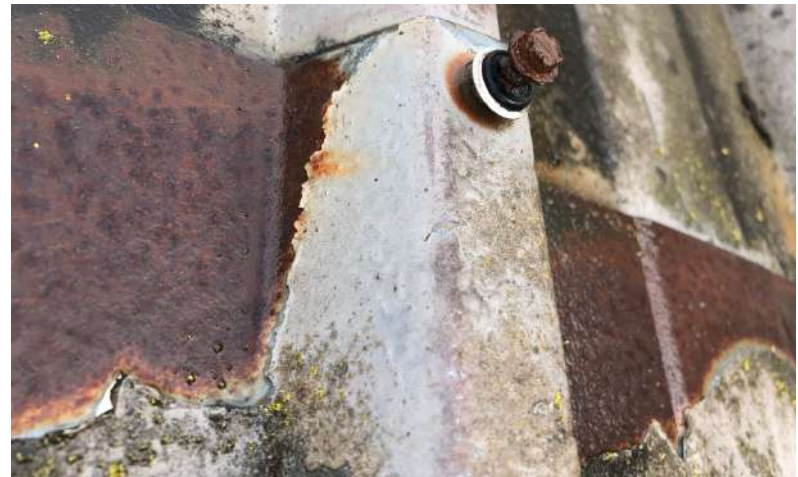
BEFORE

The existing GRP roof lights were covered by organic matter and had started to completely breakdown due to UV exposure and general weathering, the condition of the sheets stopped any type of day light transmitting into the areas below.

The GRP sheets had become completely fibrous and small holes and cracks had formed into the sheets causing water ingress on to areas below, there was also evidence of previous issues owing to various applications of sealants around the fittings and joints.

The GRP roof lights fitted came complete with a 25-year life expectancy.
