## **CASE STUDY 00016 - Discovery Retail Park, Grantham**

Commercial Roof and Gutter Refurbishment

SAND01/0008

- ▶ **Date of Project:**  
November 2001 - January 2022
- ▶ **Project Location:**  
Discovery Retail Park, Grantham
- ▶ **Project Type:**  
Commercial Roof, Cladding and Glazing  
Frame Refurbishment.
- ▶ **Contract Type:**  
Sub-Contractor
- ▶ **Contract Value:**  
£52,000.00

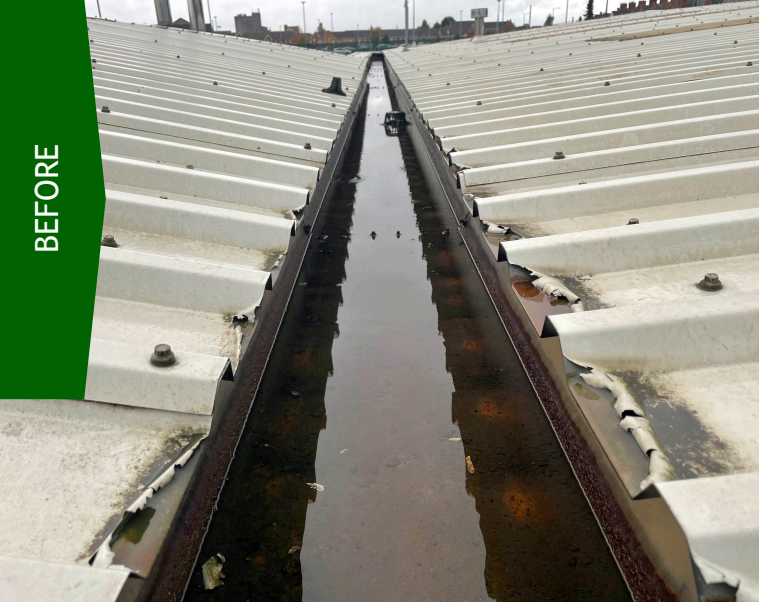
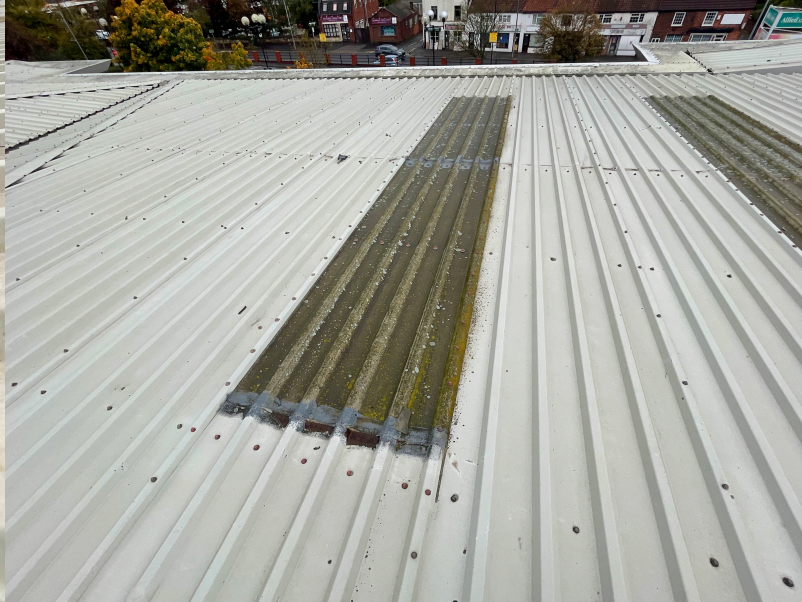
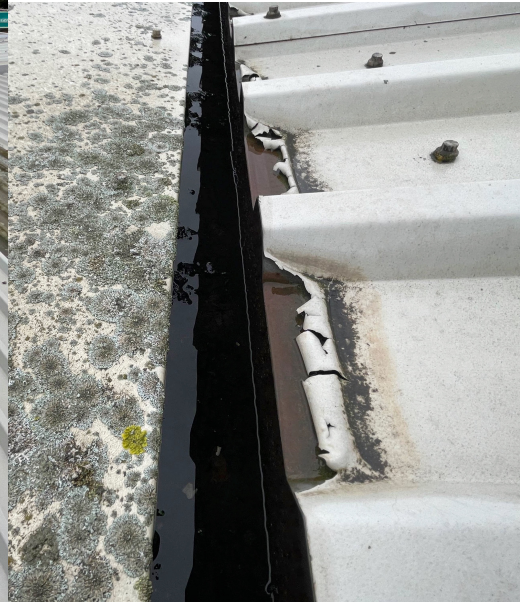
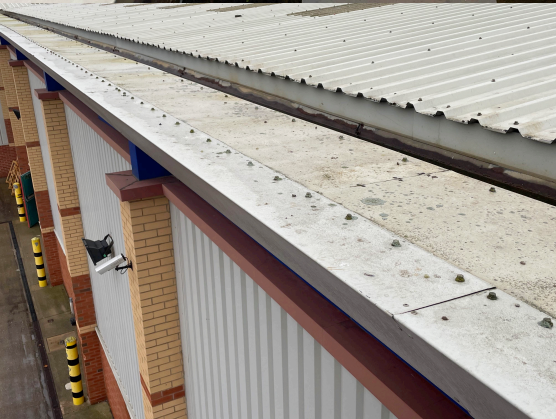
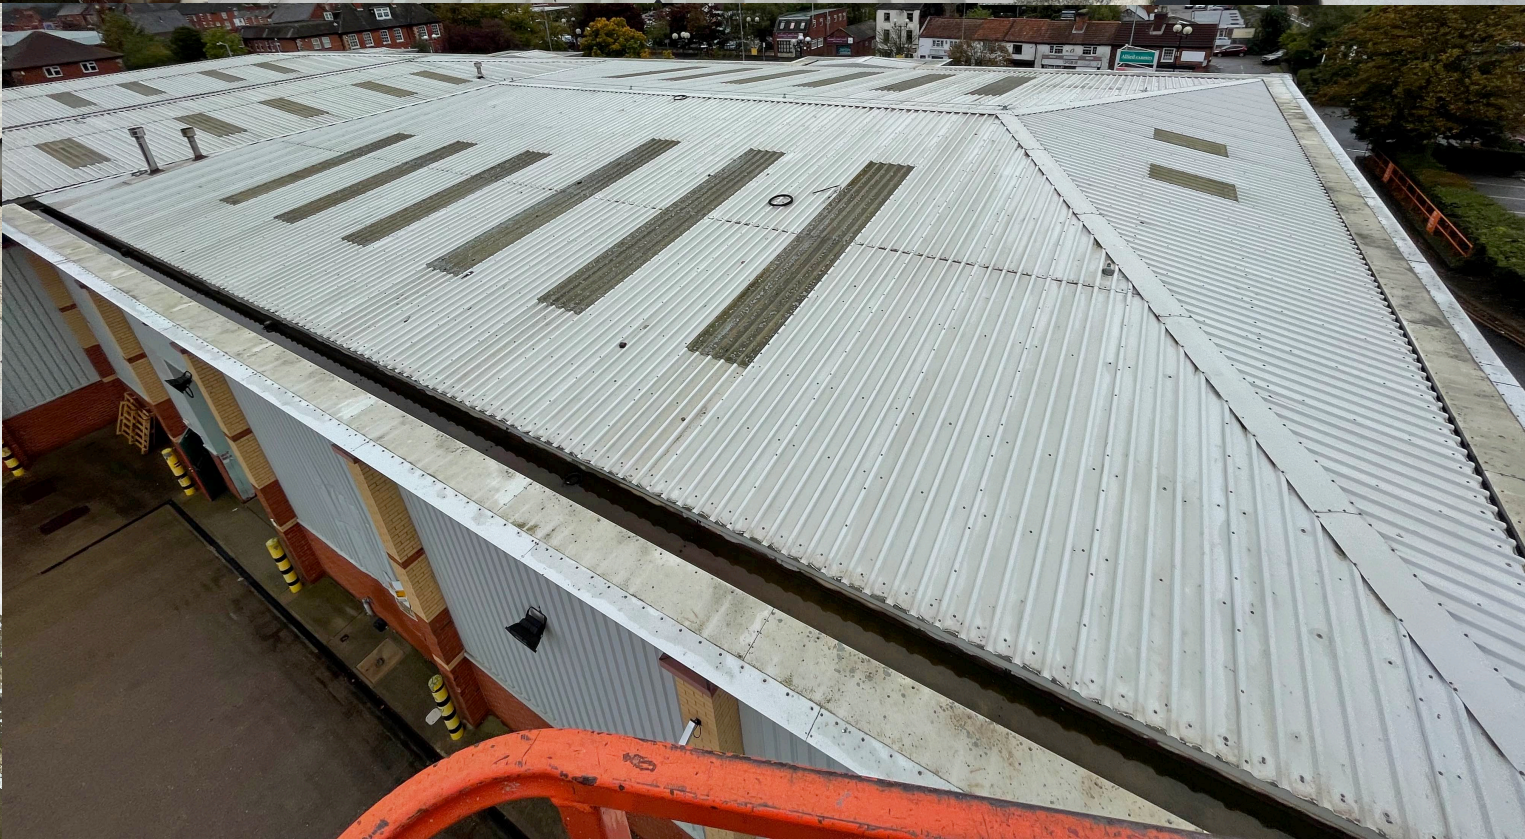
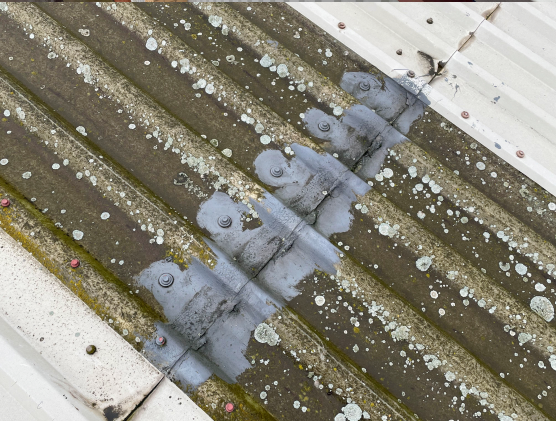
BEFORE

*During the works we changed various sections of cladding and roofing sheets owing to impact damage and large penetrations following the removal of services.*

We carefully removed the damaged sheets and sills and replaced with matching profiles, fixed and sealed to leave watertight. This also included replacing the internal liner panels where penetrations were left following the removal of services.
