CASE STUDY 00002 - Beta Way, Egham

Commercial Roof Refurbishment

- Date of Project: November 2020
- Project Location: Beta Way, Egham
- Project Type: Commercial Roof Refurbishment
- Contract Type: Sub-Contractor
- ► Contract Value: £25,000.00

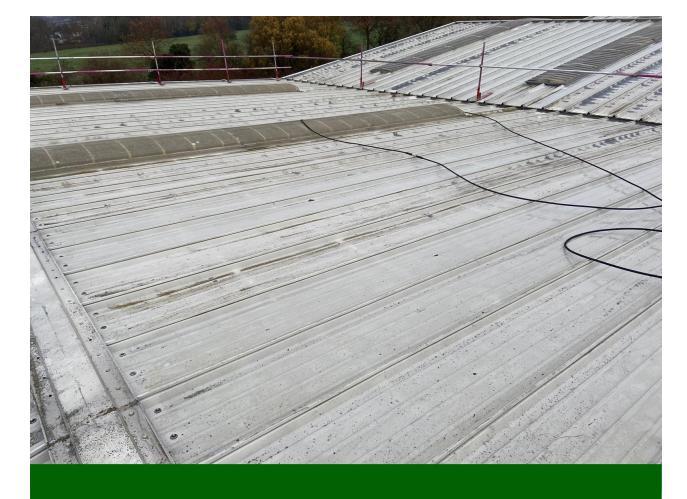
Before

The original factory applied coatings to the metal standing seam roof had completely perished due years of degradation owing to UV exposure and general weathering.

There was various surface corrosion and gingering through out the roof.

The roof sheets and flashing all suffered from cut end corrosion that would need to be addressed prior to coating the roof area.

There was also a need to remove existing fixings and caps that penetrated the roof and make good the roof sheets.

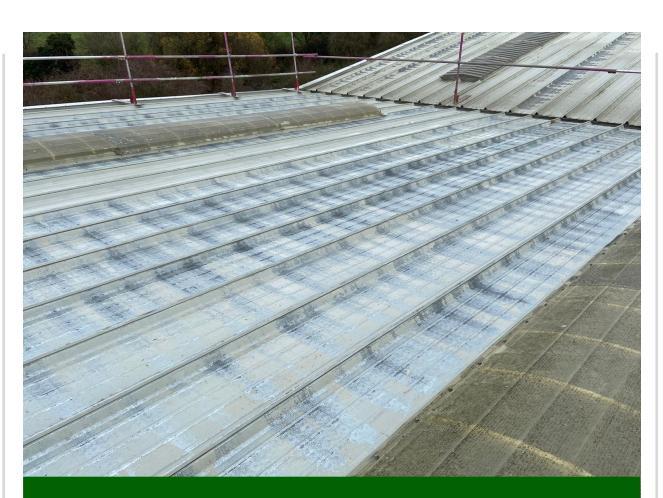
In Progress

In preparation for the coatings works, the roof was jet washed at high pressure to ensure that all loose coatings, dirt films and general contaminates were removed.

All present corrosion to the cut ends of the sheet laps, gutter edges and to the flashings are removed via machinal means.

All loose roof fixings are tightened, and any corroded fixings replaced.

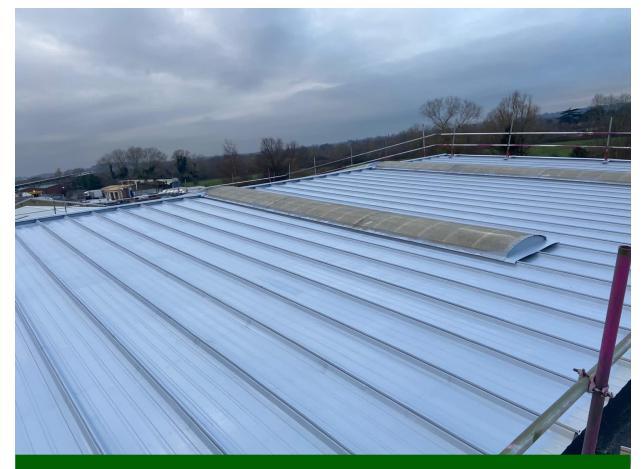
Completed

Once all the relevant preparations had been completed, all roof fixings where primed and sealed to completely encapsulate all vulnerable areas that could be subject to premature corrosion issues, this also included the priming of the prepared cut edges.

A primer is applied to the complete roof area using airless spray system, followed by a final topcoat of AkzoNobel Steel Seal III to all roof areas, this is a BBA approved coating system complete with a 10-year manufacturers guarantee.

The Akzo Nobel roof coating will extend the lifespan of the roof sheets by a further 10 years.

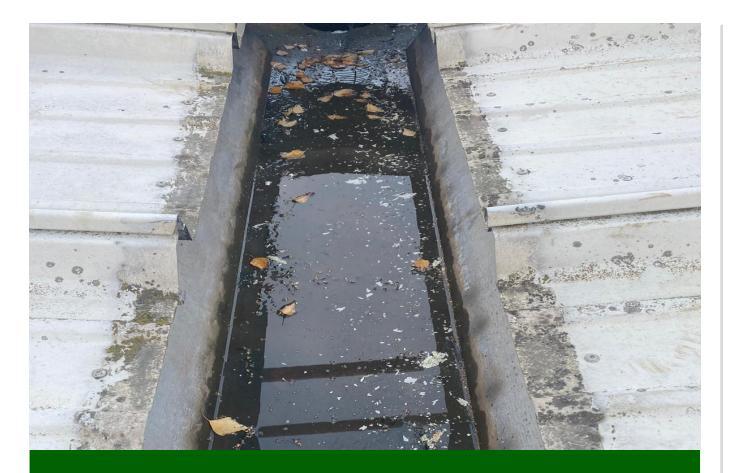
Before

The existing gutters to the roof were left unmaintained, they were full of debris which caused damming around the gutter outlets, this then results in standing water, which then accelerates corrosion to the metal box gutter substrate.

These gutters also had defective gutter joints seals that had led to many years of water ingress into the building below.

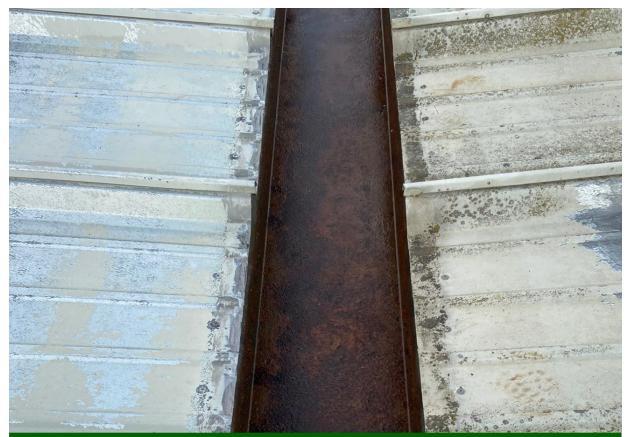
In Progress

All gutters had to be cleared of debris and silt build up, these were collected by hand and then placed in debris bags to be lowered to ground level and disposed of within the site skip.

All standing water was drained from the gutters before all loose surface corrosion was removed and then the gutters were swept and rinsed through ready for the application of the Giromax Girosil® RC-G gutter treatment.

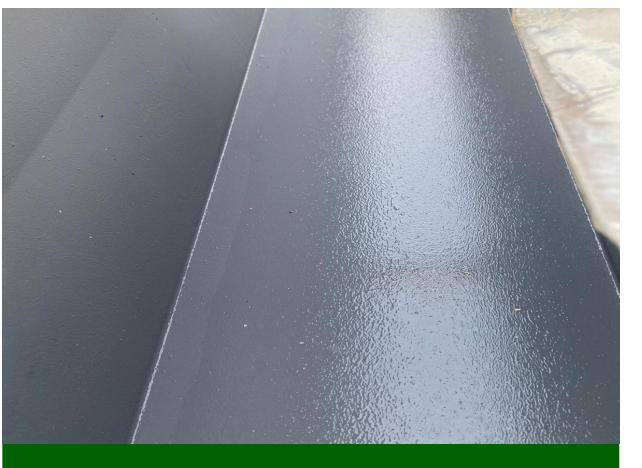
Completed

On completion of the thorough clean and clearance of the gutters all the joints were sealed using Giromax Girosil® SE to leave watertight, then all the complete length of gutters were primed and then coated with the Giromax Girosil® RC-G system.

As a fully trained and approved applicator of Giromax systems, all works were signed off and supplied with a 15-year manufacturers guarantee supplied by Giromax.

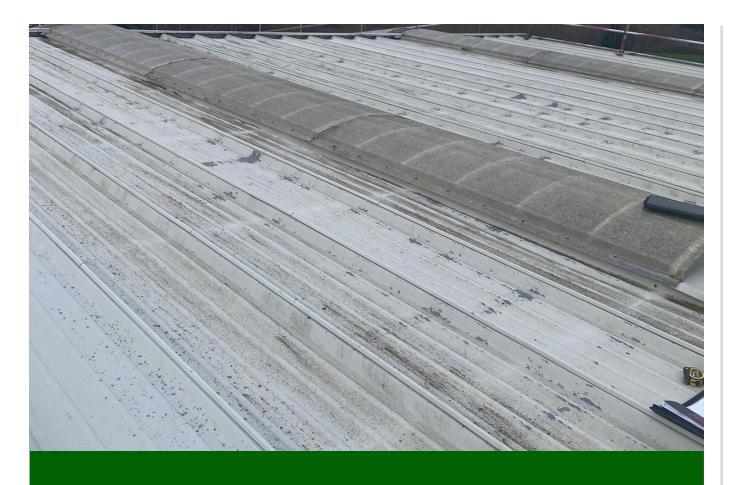
Before

The existing outer skin on the GRP roof light sheets had eroded and started to breakdown due to UV exposure and general weathering, the condition of the sheets had seriously reduced the amount of natural day light that could transmit through the voids and into the warehouse.

Not only does this reduce the light but makes the building consume more energy in lighting the warehouse during day light hours.

The GRP sheets had become fibrous and small holes and cracks had formed into the outer sheets causing water ingress on to the inner sheets below.

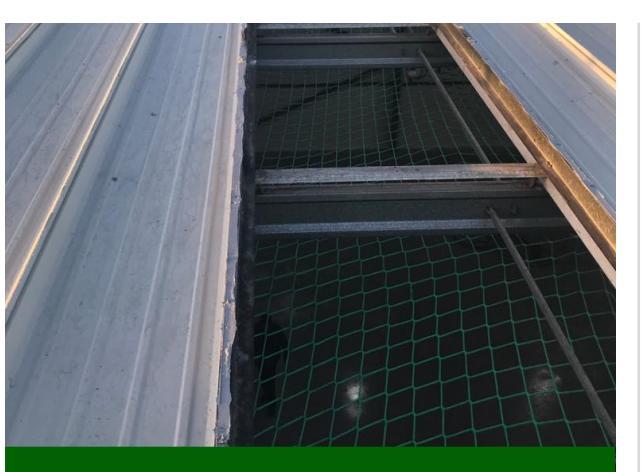
In Progress

The outer defective and redundant roof sheets where carefully removed and transported from the roof and disposed off in the site skip. All previously sealants and corroded fixings removed ready to be replaced with new.

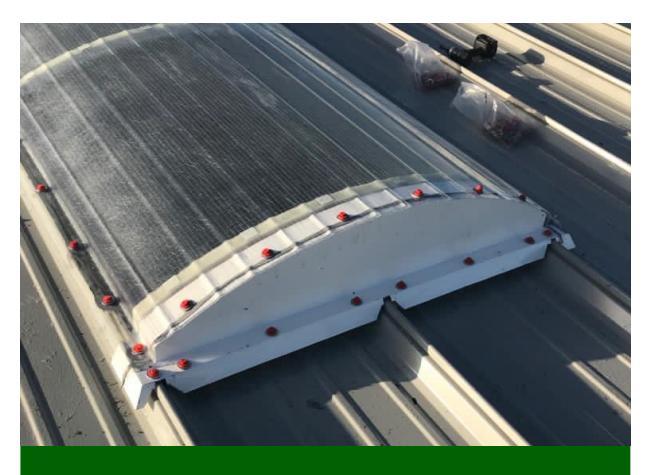
Completed

New Filon Monarch sheets were then supplied and fitted along with new fixings, stop ends and flashing details.

We used bright poppy red capping's over the the heads of the new fixings to highlight the fragile roof area.

The difference in light transmission was instant lighting up the warehouse.
