CASE STUDY 00019 - RM Delivery Office, Leominster

Commercial Roof, Gutter & Cladding Refurbishment

CASE STUDY - KEYP01/0026

- Completion of Project: September 2023
- Project Location: Royal Mail Delivery Office, Leominster
- Project Type: Commercial Warehouse Refurbishment
- Contract Type: Sub - Contractor
- Contract Value: £35,500.000

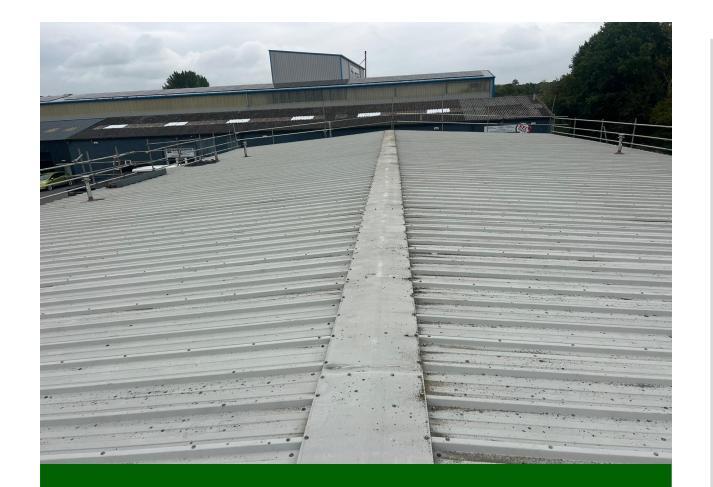
Before

The original factory applied coatings to the metal sheets has had completely perished due years of degradation owing to UV exposure and general weathering.

There was various surface corrosion and gingering through out the roof.

The roof sheets and flashing all suffered from cut edge corrosion that would need to be addressed prior to coating the roof area.

There was also a need to remove existing fixings and caps that penetrated the roof and make good the roof sheets.

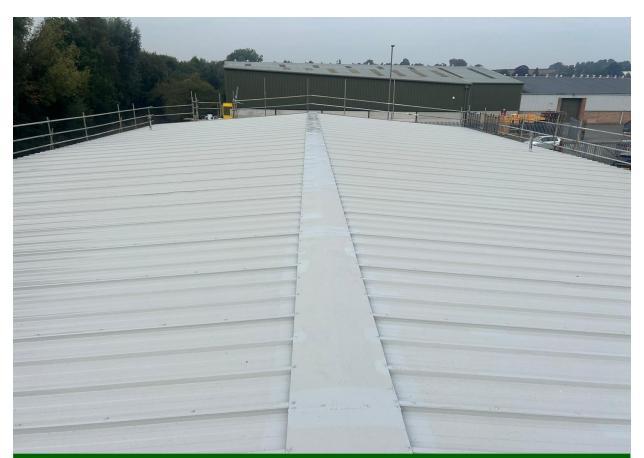
In Progress

In preparation for the coatings works, the roof was jet washed at high pressure to ensure that all loose coatings, dirt films and general contaminates were removed.

Removed existing fixings or caps that were perished or heavily corroded prior to the roof coating.

All loose roof fixings are tightened, and any corroded fixings replaced.

All flashing and parapets incorporated with full roof coating.

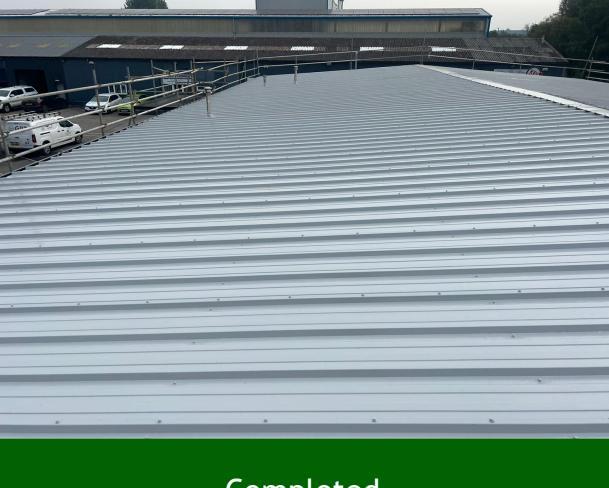
Completed

Once all the relevant preparations had been completed, all roof fixings where primed and sealed to completely encapsulate all vulnerable areas that could be subject to premature corrosion issues, this also included the priming of the prepared cut edges.

Once all the preparation is complete on the roof area, Giromax® Roofcoat is applied to all roof areas, this is a BBA approved coating system complete with a 25-year manufacturers guarantee.

The Giromax® Roofcoat coating will extend the lifespan of the roof sheets by a further 25 years.

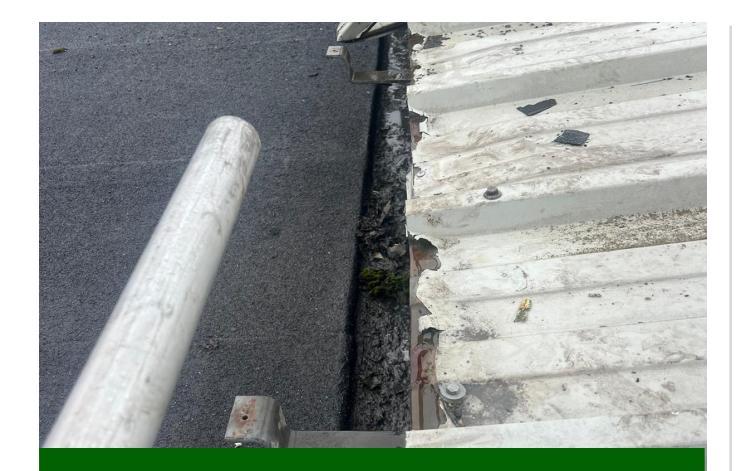
Before

The existing gutters to the roof were left unmaintained full of debris, standing water causing surface corrosion throughout.

Due to lack of maintenance the joints were also leaking and causing water ingress to the warehouse directly below.

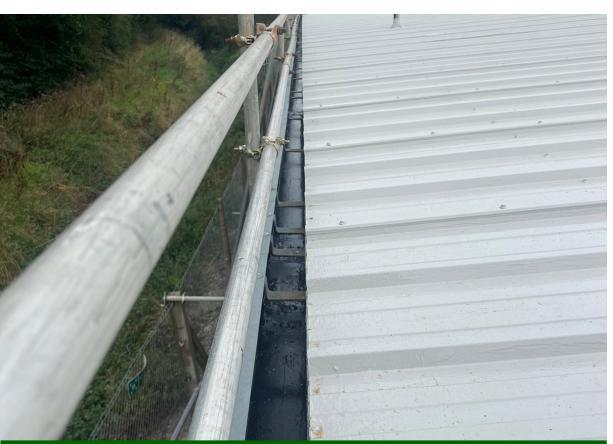
In Progress

All gutters had to be cleared of debris and silt that had been built up in the gutters, these were collected, bagged up and removed from the roof.

Once cleared of standing water and any debris, the gutters were then abraded by mechanical means to provide a key for the gutter treatment.

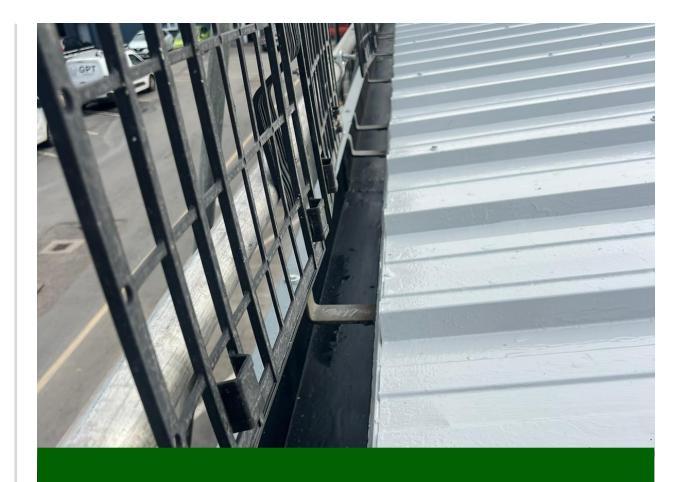
Completed

Following the clean and initial abrading to the gutters and joint surfaces we then primed and sealed ready these areas to receive the Giromax® Gutter coating. This system comes complete with a 15-year guarantee.

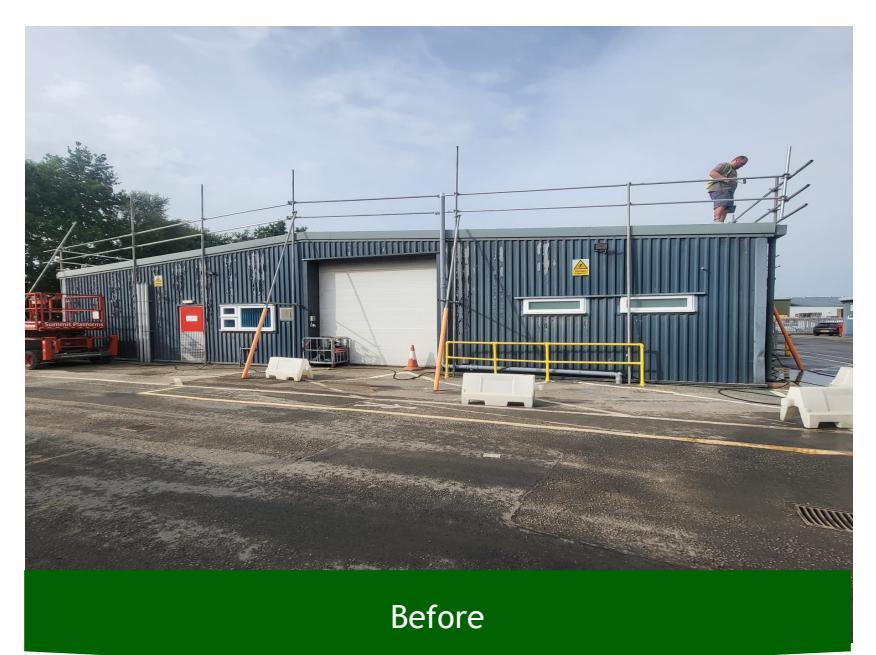
The original factory applied plastisol coatings to the steel cladding sheets had started to perished due to years of degradation owing to UV exposure and general weathering.

There were hundreds of redundant fixing holes throughout the cladding elevations owing to signage and various other fixings being installed and then removed over the years of occupancy by the tenants.

The redundant fixing holes were filled using a two-part body filler, sanded back and then spot primed.

Once all filling had been completed the cladding was then washed down to remove all dirt films, bird droppings and other contaminates.

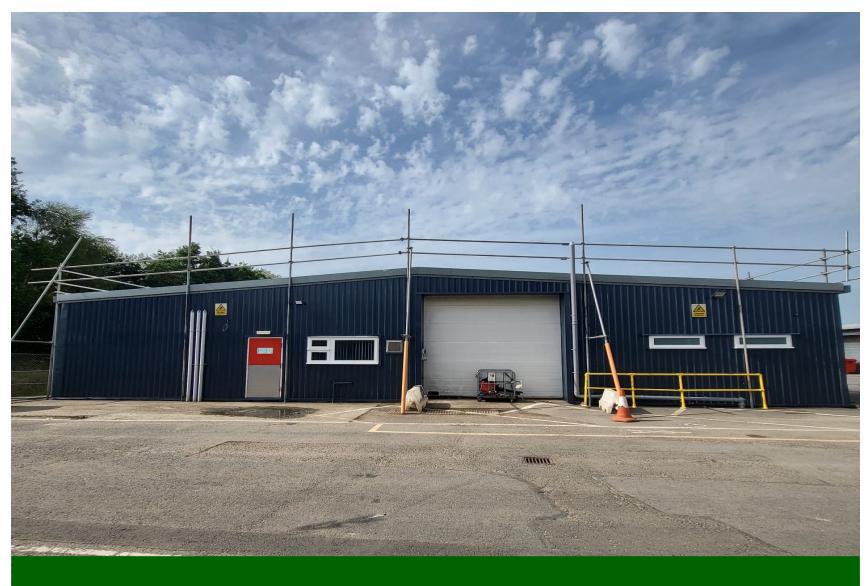
Completed

Once all the relevant preparation works had been completed, our operatives masked up all the masonry, doors and other vulnerable areas within the immediate area to protect them from potential paint over spray.

The operatives then applied the coatings in Grey Blue (RAL 5008) and to the main body of the profiled cladding sheets via a combination of different application methods which included airless spray, HVLP and roller.

Once completed the cladding coating works were issued with a 20-year guarantee from the manufacturer.
