## **CASE STUDY 00015 - Clifton Road, Cambridge**

Commercial Cladding Refurbishment

REDW01/0060

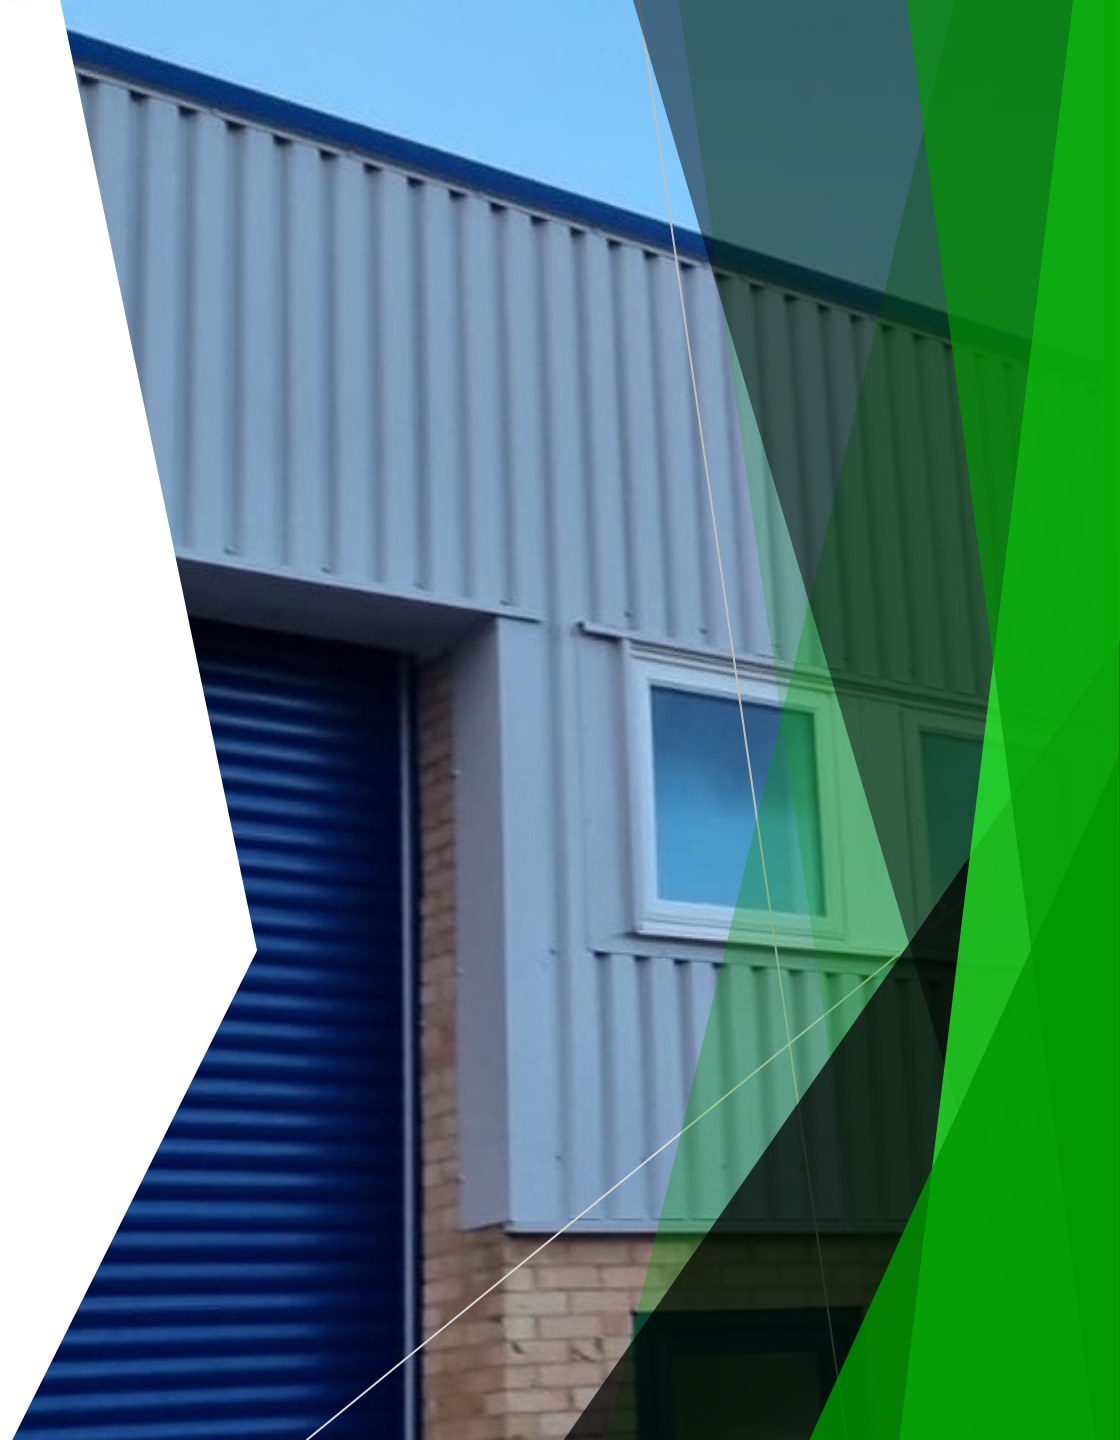
- **250 m2 of cladding refurbishment** - Our operatives prepared the cladding by filling over 500 No. of redundant fixing holes throughout the building elevations, once filled and sanded back and primed, the cladding was washed down throughout to remove the build up of all dirt films and bird droppings. Then a 10 Year Tikkurila Temadur 20 coating system was applied by a mix of paint systems such as Airless, HVLP and roller.

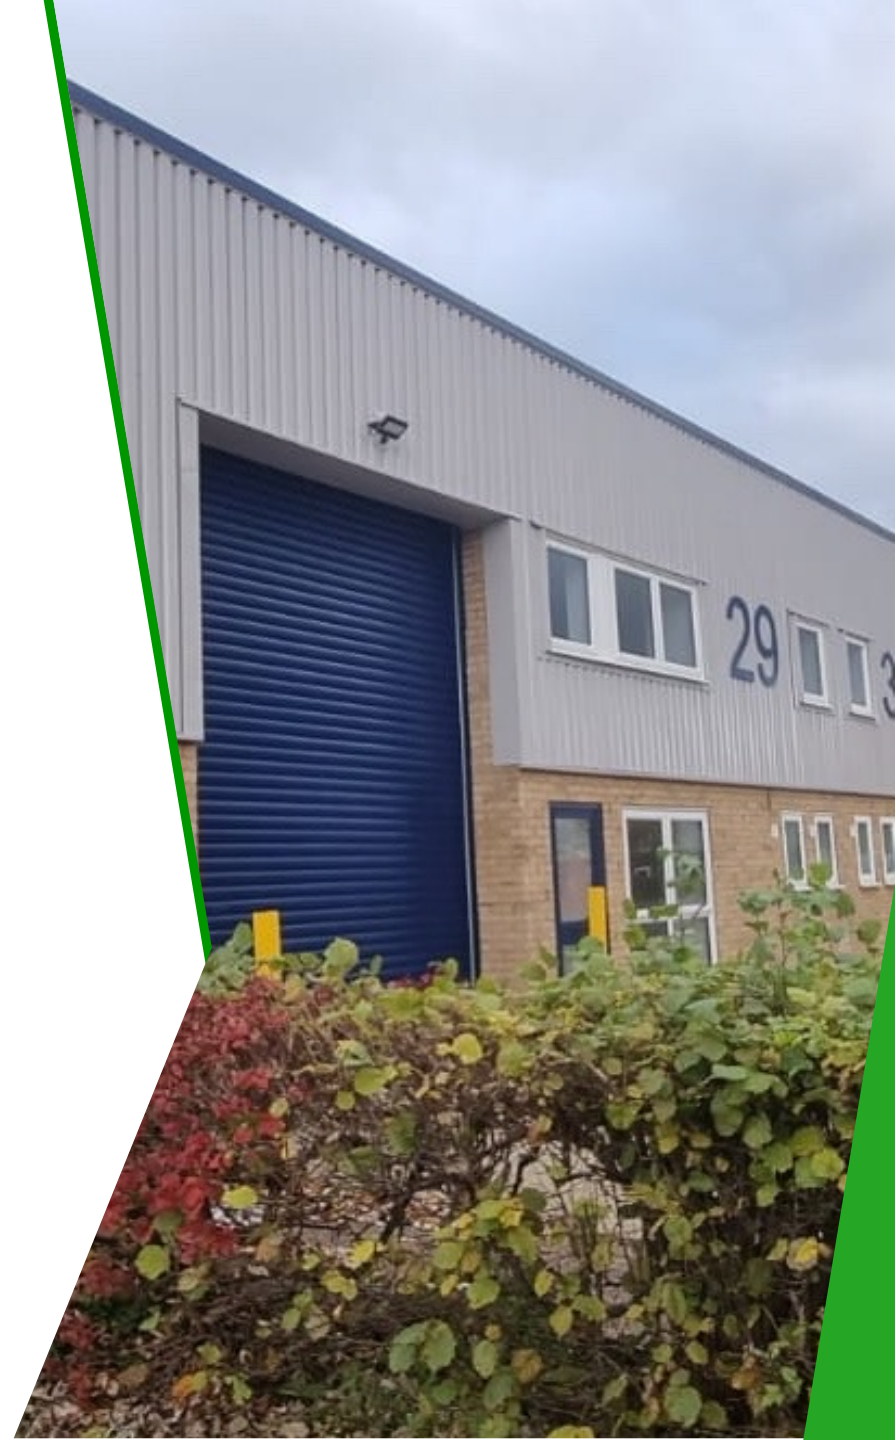
*The existing cladding consisted of brown weathered plastisol coated steel cladding that had eroded over many decades causing it to fade, there was many fixing holes accumulated over the time of previous occupancy following the installation and removal of signage and fixings.*

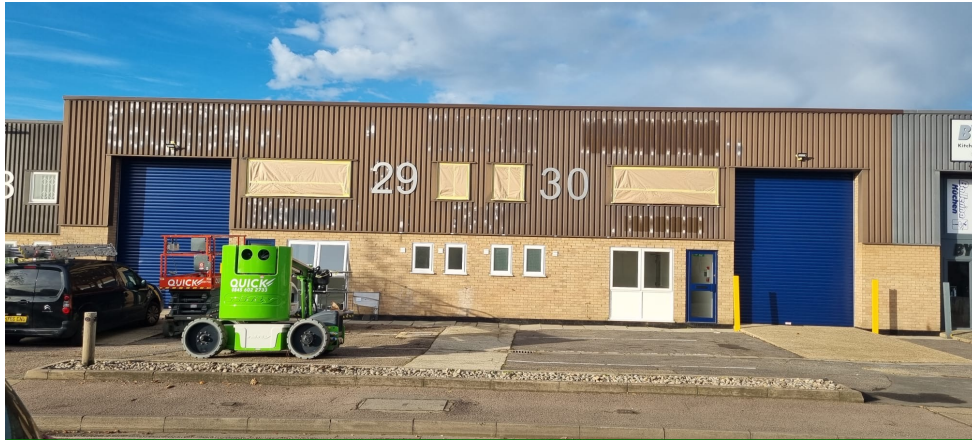
Before

The original factory applied plastisol coatings to the steel cladding sheets had started to perished due to years of degradation owing to UV exposure and general weathering.

There were hundreds of redundant fixing holes throughout the cladding elevations owing to signage and various other fixings being installed and then removed over the years of occupancy by the tenants.

The redundant fixing holes were filled using a two-part body filler, sanded back and then spot primed.

Once all filling had been completed the cladding was then washed down to remove all dirt films, bird droppings and other contaminates.

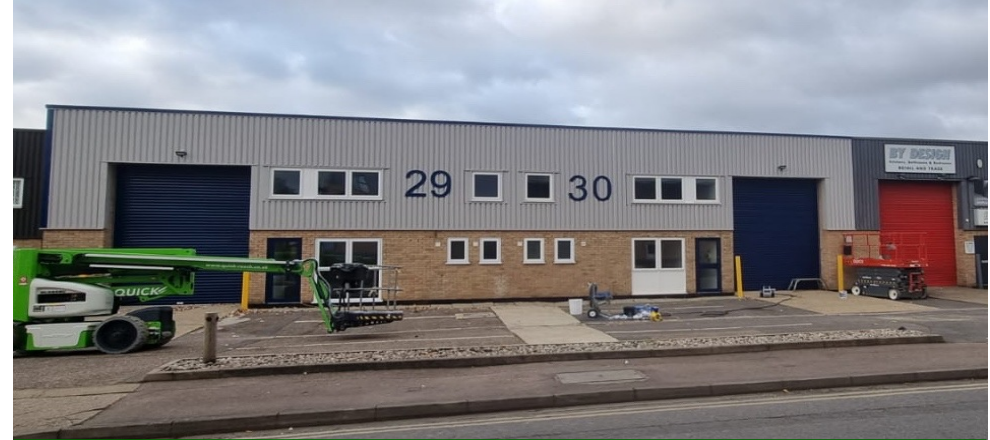
After

Once all the relevant preparation works had been completed, our operatives masked up all the masonry, windows, doors and other venerable areas within the immediate area to protect them from potential paint over spray.

The operatives then applied the coatings in Goosewing Grey to the main body of the profiled cladding sheets via a combination of different application methods which included airless spray, HVLP and roller.

Once the main body of the cladding had been coated in grey and fully cured, the trims and unit numbers were coated in a contrasting Sargasso Blue to give the unit a tidy pristine finish and new lease of life ready for potential tenants.

Once completed the cladding coating works were issued with a 10-year guarantee from the manufacturer.
