CASE STUDY 00015 - Clifton Road, Cambridge

Commercial Cladding Refurbishment

Commercial Box Profile Cladding Refurbishment

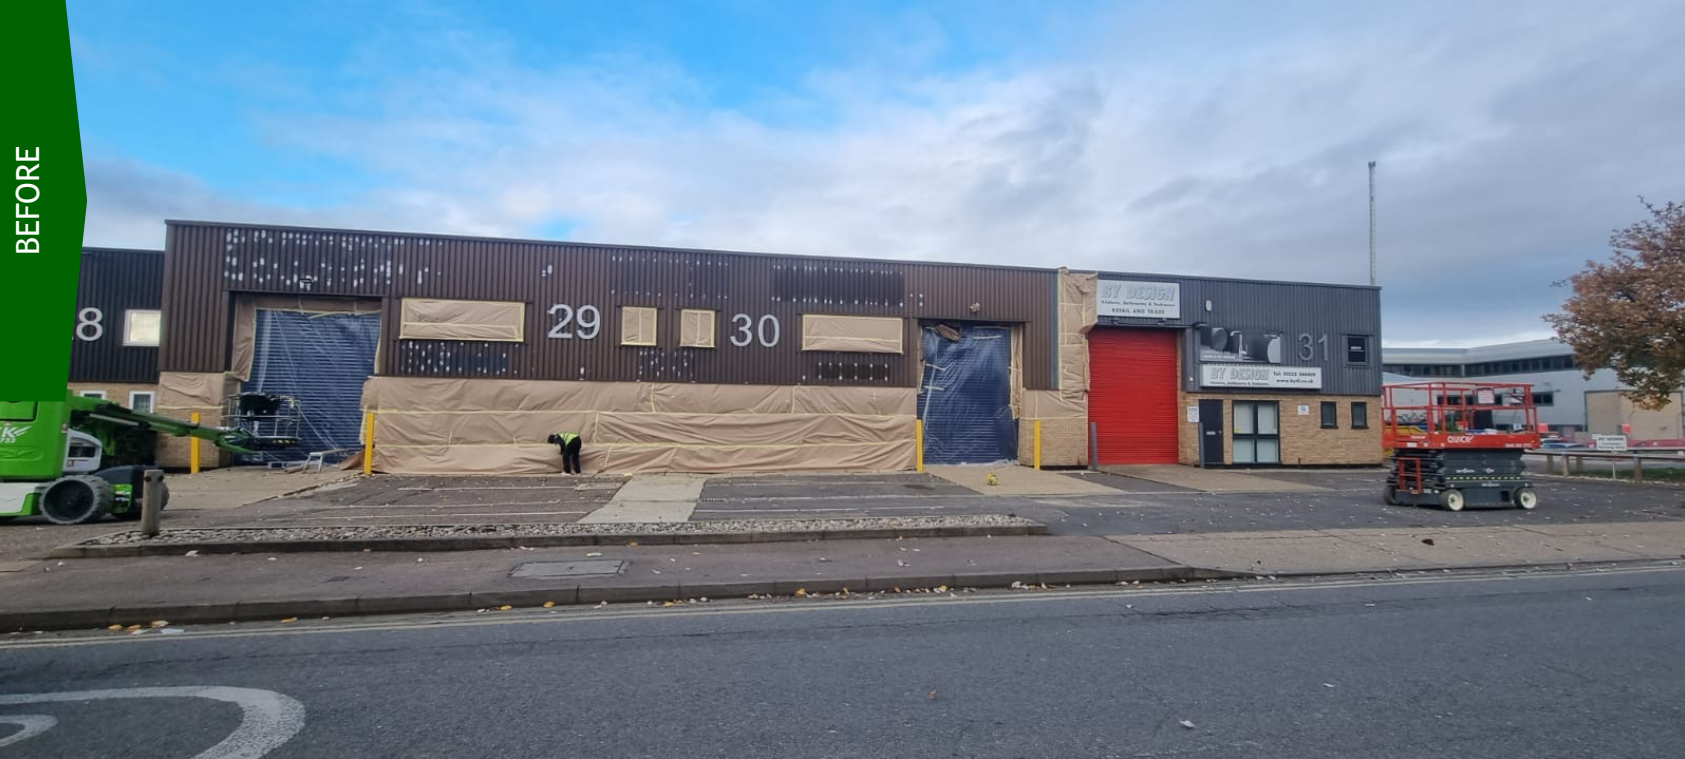
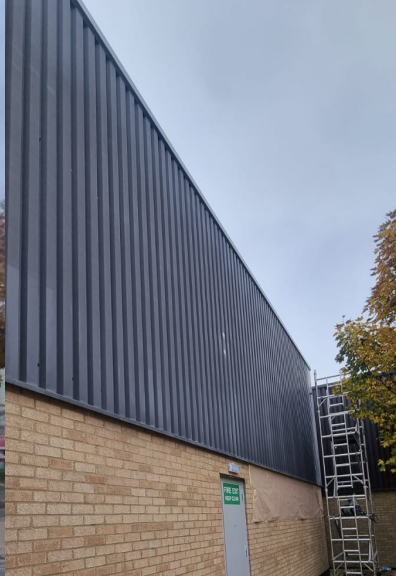
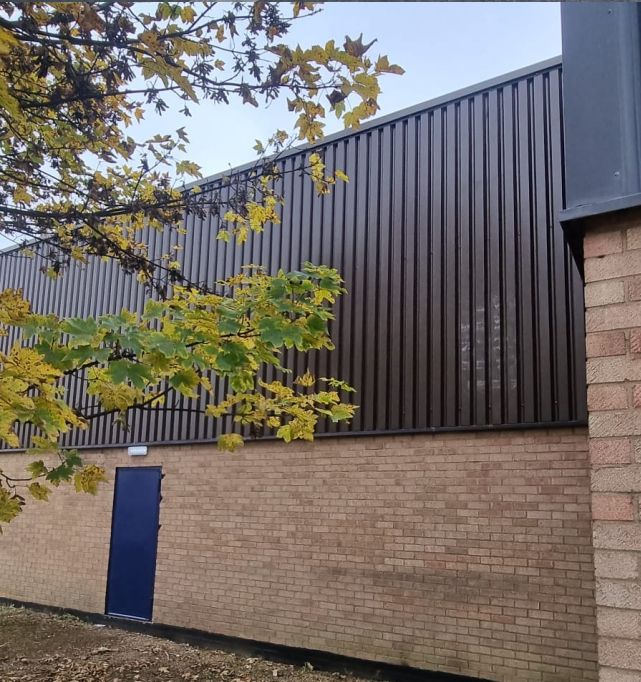
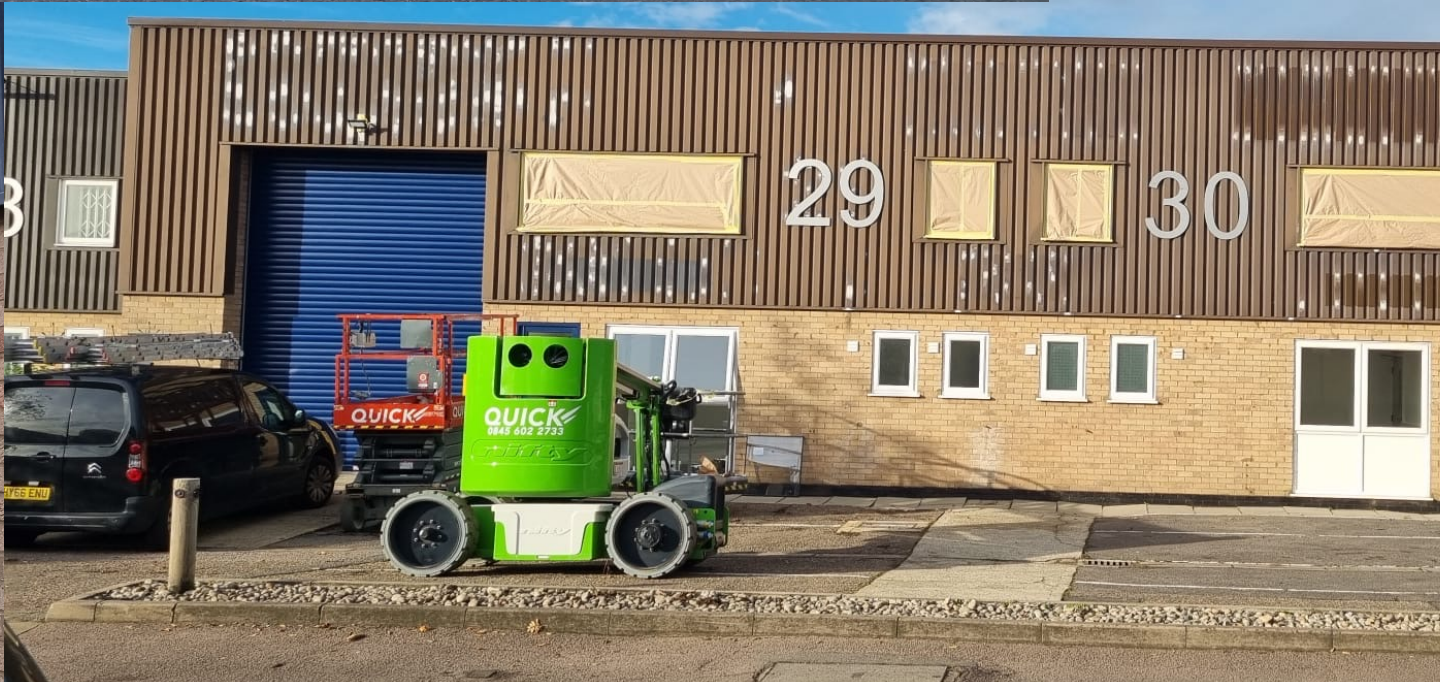
BEFORE

The existing cladding consisted of brown weathered plastisol coated steel cladding that had eroded over many decades causing it to fade, there was many fixing holes accumulated over the time of previous occupancy following the installation and removal of signage and fixings.
